ASSESSMENT OF SEWER LIFT STATIONS AND NORTH COAST INTERCEPTOR

APRIL 2003

City of Laguna Beach

Boyle Engineering Corporation

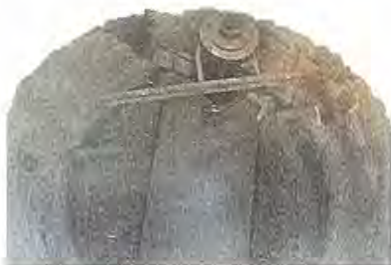
*Air release valve on PCH.
Some odor detected.*

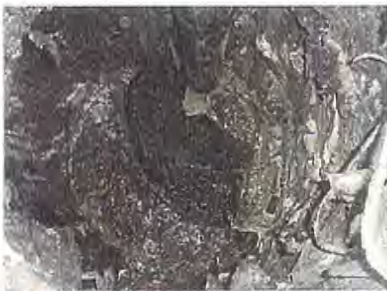
Significant corrosion and lining failure in manhole leading to Bluebird Lift Station

Project Number	Project Description
20	Rehabilitate Manholes on VCP Gravity Segment - rehabilitate the manholes on the VCP gravity segment by repairing and lining the base and shaft sections and replacing the manhole adjacent to the Bluebird Lift Station.
21	Construct Manholes on FRP Pipe Gravity Segment - construct conventional gravity sewer manholes at each end of the two siphons and at standard spacing on the remainder of the FRP pipe gravity segment.
22 23	Rehabilitate the Existing ACP Force Mains - rehabilitate the two existing ACP force mains as necessary after construction of the parallel force mains by lining.

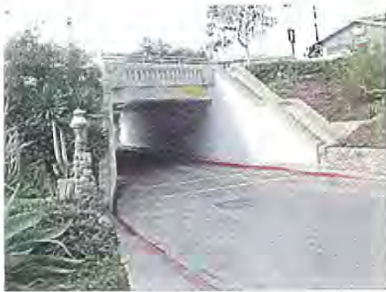
Location of siphon at PCH undercrossing at Nyes Place.

Project Number	Project Description
16	Nyes Place Siphon Rehabilitation - rehabilitate the existing corroded steel pipe reach in the siphon at Nyes Place by insertion of a liner. Investigate revising the profile at the bottom section to eliminate the local high point.
17	Parallel Force Main from Laguna Lift Station - construct a parallel force main from the Laguna Lift Station to the beginning of the VCP gravity segment at Catalina St. and El Camino.
18	Parallel Force Main from Bluebird Lift Station - construct a parallel force main from the Bluebird Lift Station to the beginning of the FRP pipe gravity segment in the Pacific Coast Highway at Victoria Place.
19	Relocate Portion within Aliso Creek - relocate the portion of the gravity siphon segment that is directly within the Aliso Creek channel.

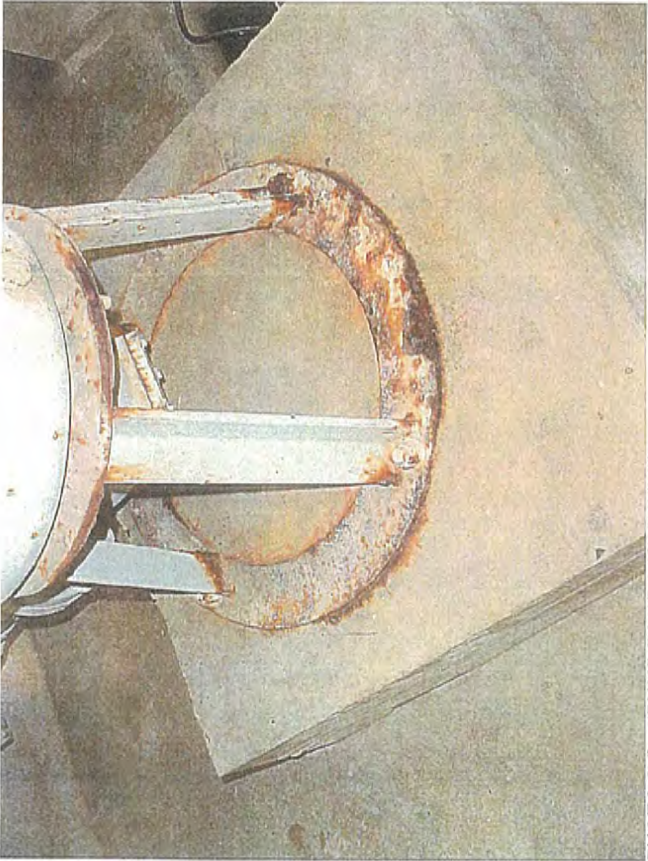
PHOTO 2-5 PUMP BASE CORROSION
12/24/2002 (Tue), 10:21 AM

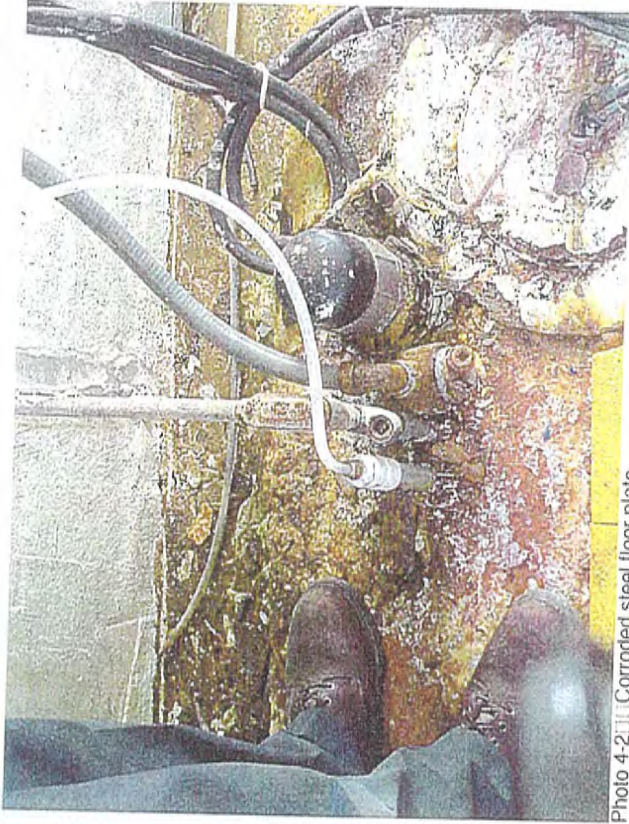
Photo 4-2: Corroded steel floor plate
MVC-161F.JPG
12/18/2002 (Wed), 2:14 PM

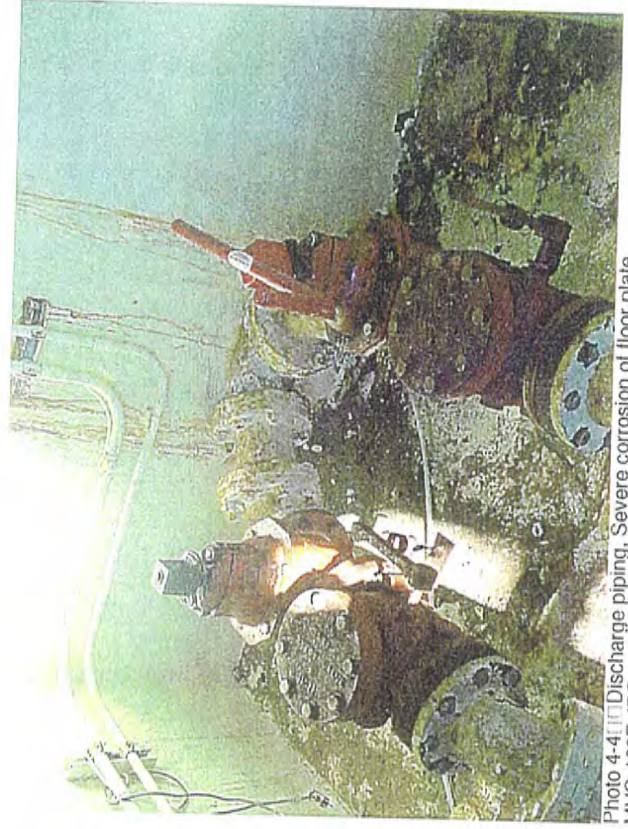
Photo 4-4: Discharge piping, Severe corrosion of floor plate
MVC-163F.JPG
12/18/2002 (Wed), 2:14 PM

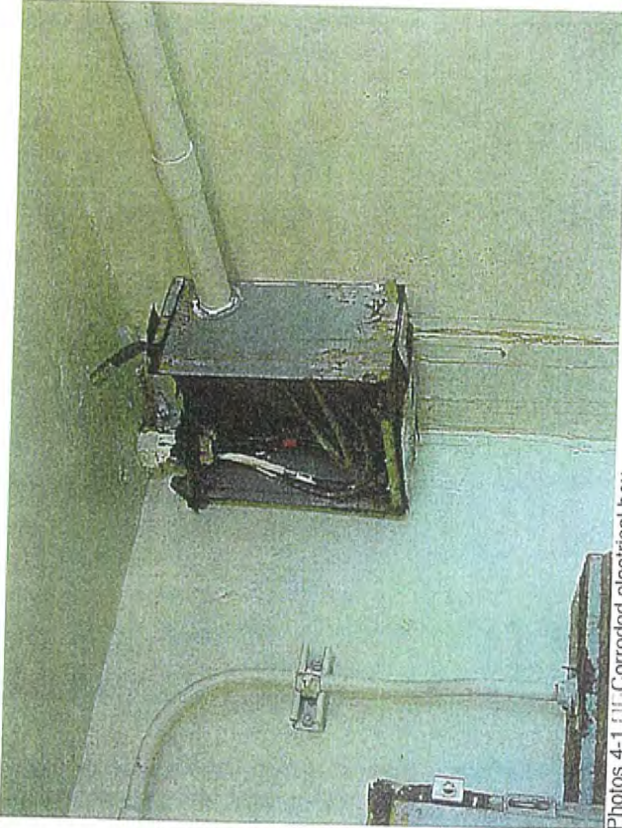
Photo 4-1: Corroded electrical box
MVC-160F.JPG
12/18/2002 (Wed), 2:14 PM

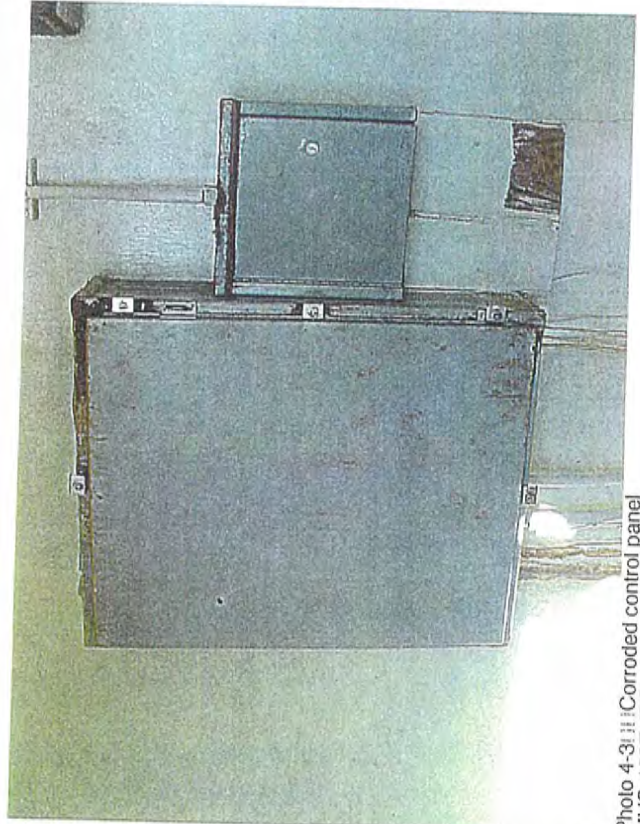
Photo 4-3: Corroded control panel
MVC-162F.JPG
12/18/2002 (Wed), 2:14 PM

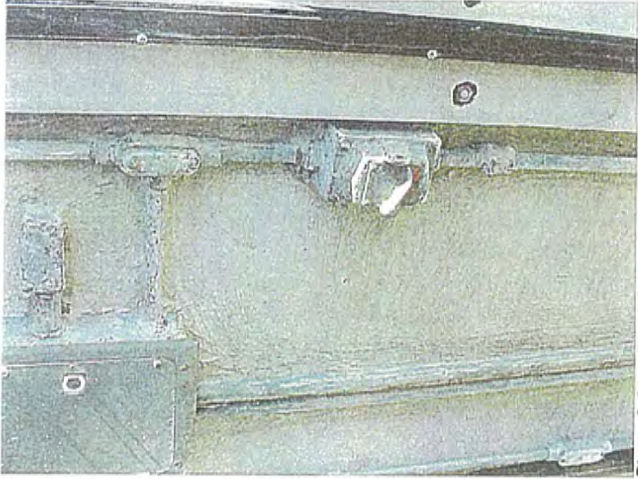
Photo 8-6 Corroded switch
12/18/2002 (Wed), 12:58 PM

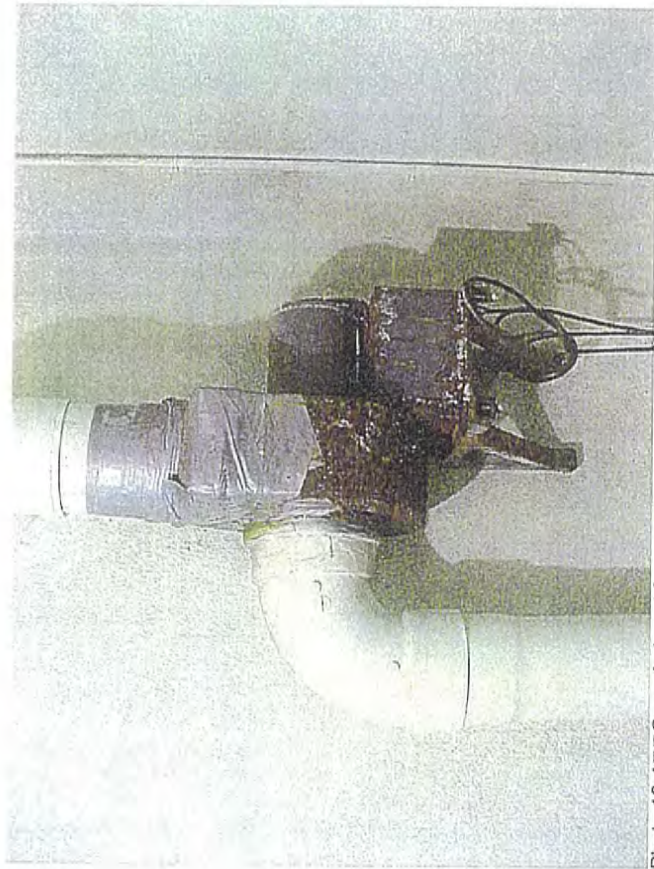
Photo 13-1 Corroded vent fan
12/18/2002 (Wed), 11:09 AM

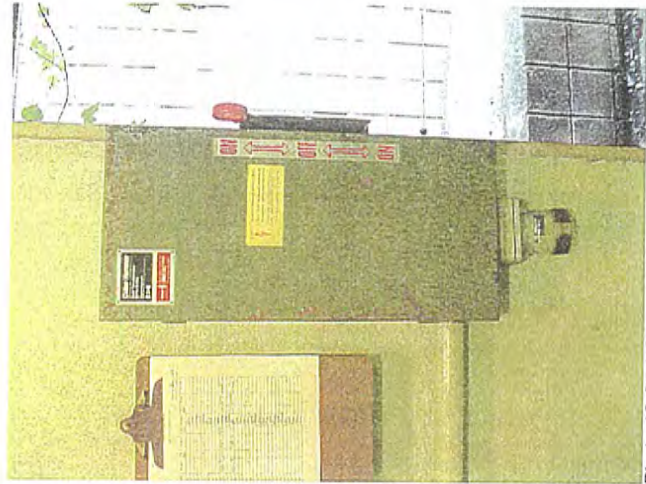
Photo 13-2 Corroded transfer switch panel
12/18/2002 (Wed), 11:10 AM

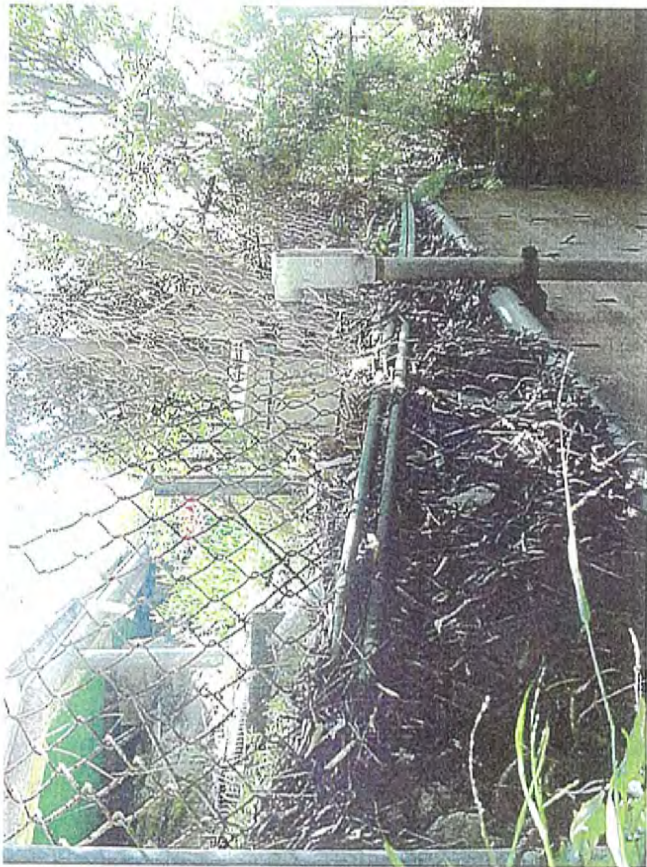
Photo 16-1: Station entry is subject to flooding from adjacent property
12/18/2002 (Wed), 10:26 AM

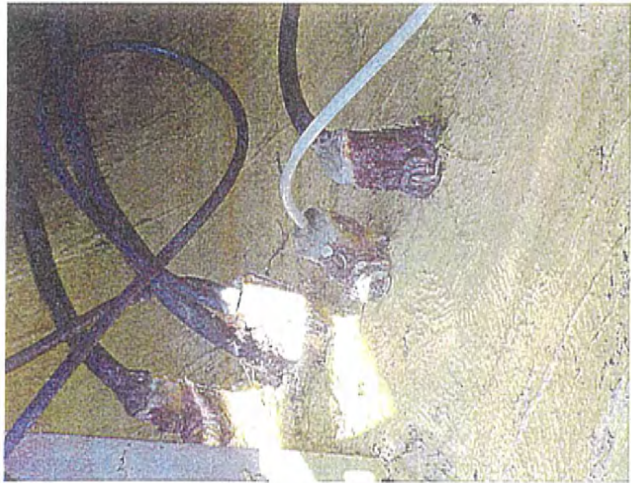
Photo 22-9 Corroded Fitting In Pump Wet Well
DSC00024a20.JPG
12/24/2002 (Tue), 11:09 AM
