South Orange County Wastewater Authority  
34156 Del Obispo Street  
Dana Point, CA 92629

**Biological Resources Damage Assessment  
for the  
North Coast Interceptor Force Main Spill  
of  
November 27-29, 2019**

**Dwight Mudry, Ph.D.  
Environmental & GIS Services, LLC**

**January 2020**

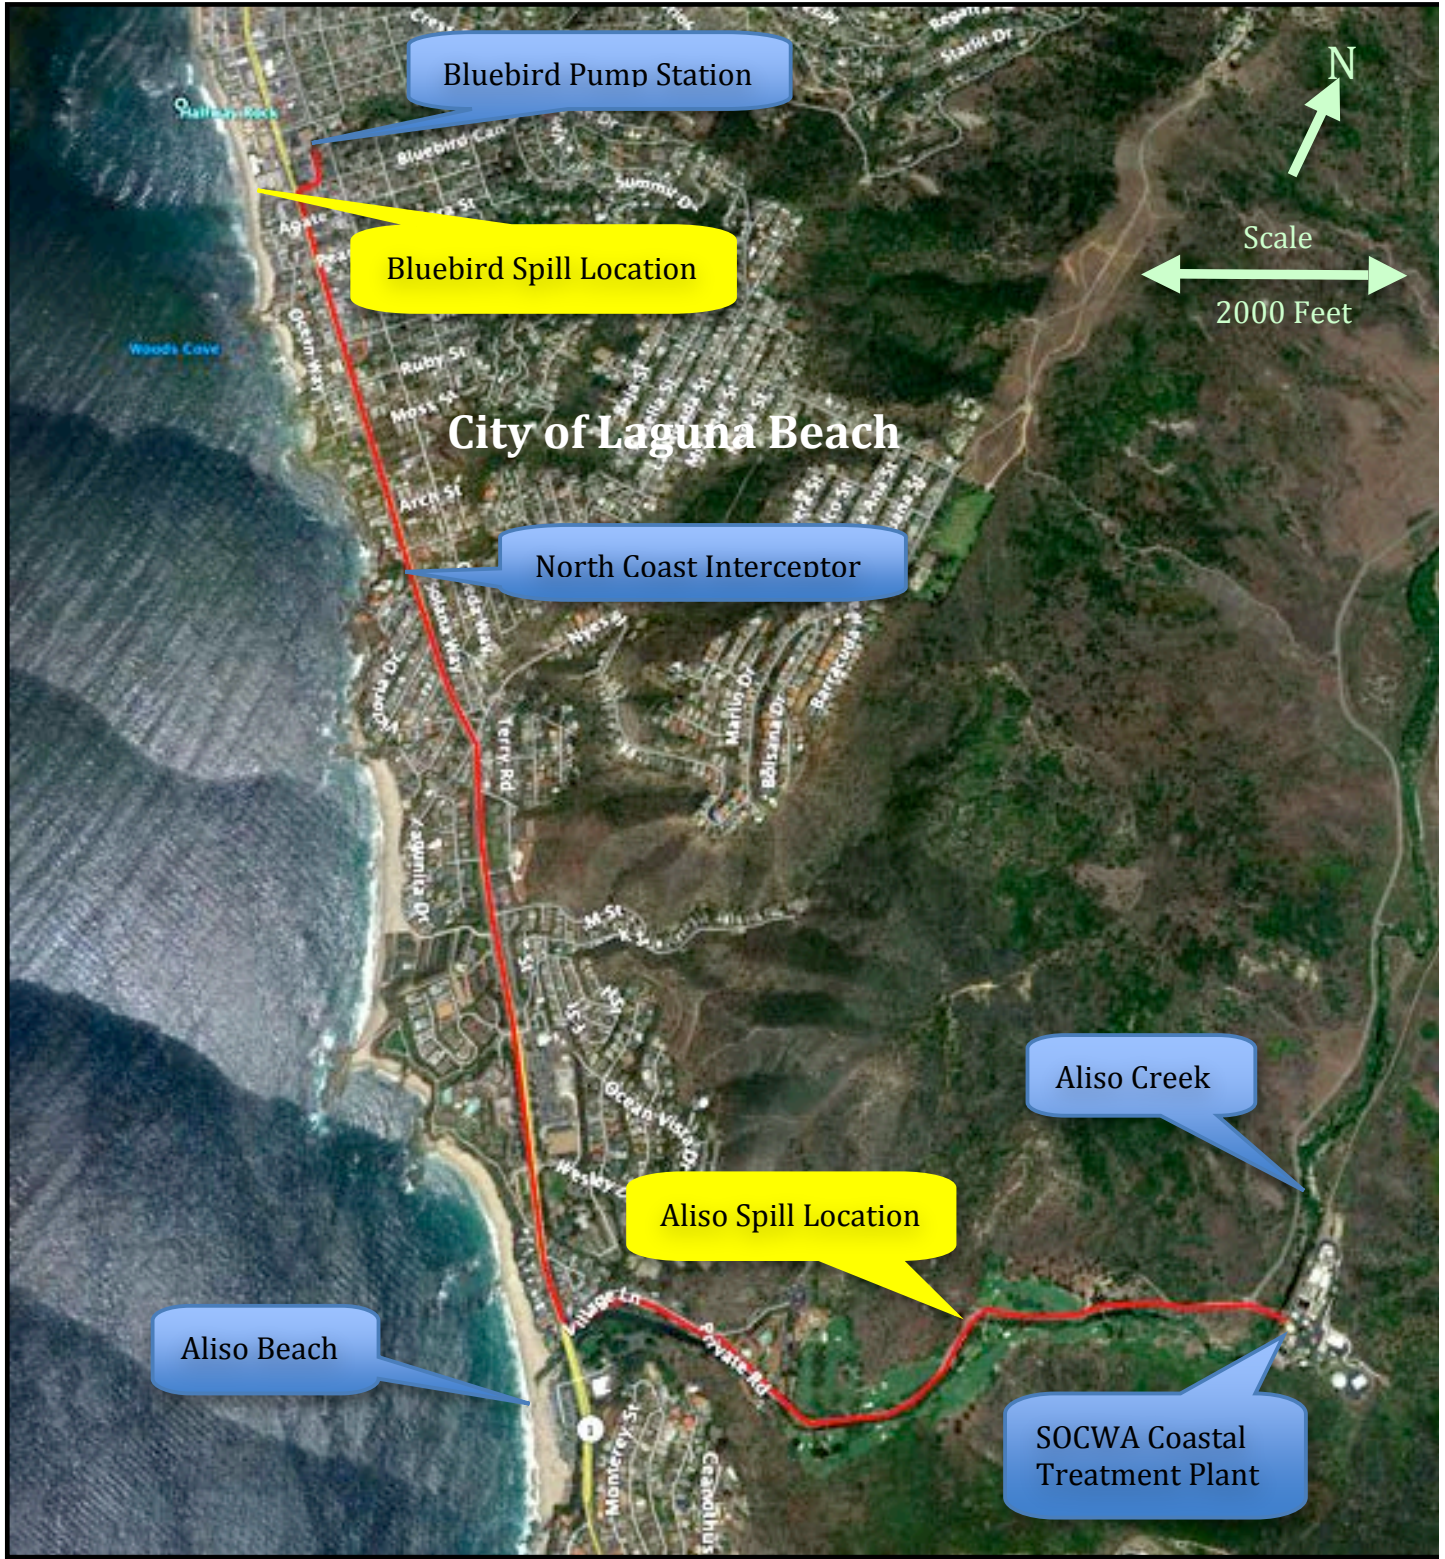
**Figure 1.** North Coast Interceptor sewer line, Aliso Creek, and spill locations.

The spill occurred at two locations identified as “Aliso Creek” and “Bluebird” in Figure 1. Characteristics of the spills at these locations are as follows:

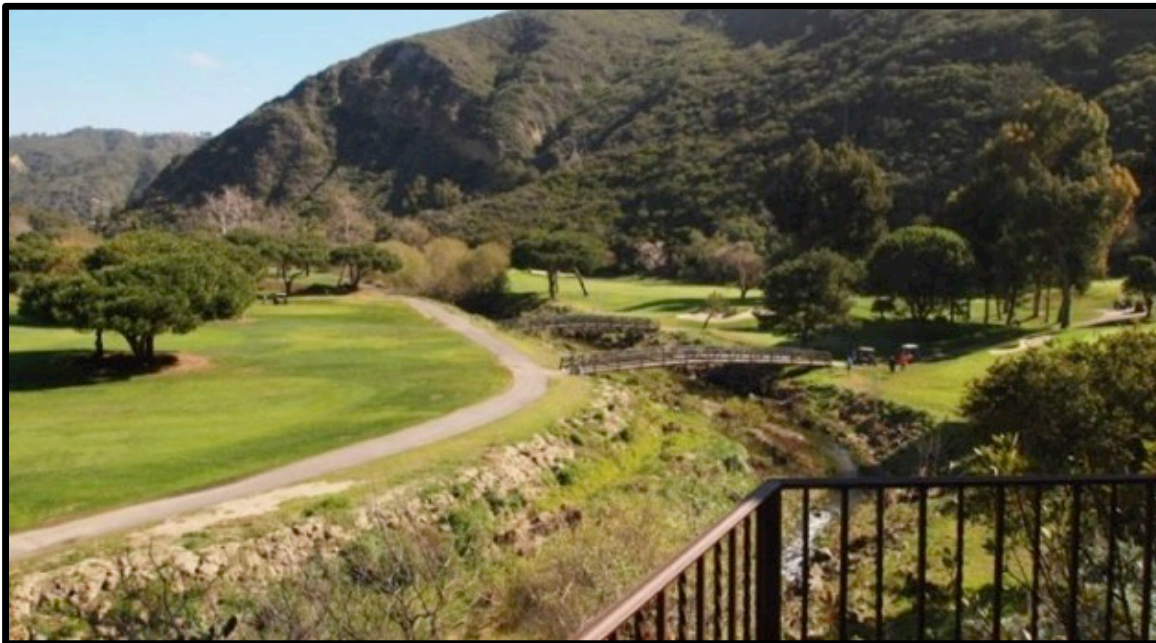
**Figure 2.** Typical view of Aliso Creek within The Ranch golf course.

The spill study area of the lower Aliso Creek drainage has topographic features, which, in combination with historic and existing land uses, influence the type and character of the study area: Aliso Canyon; Aliso Creek; the hillsides to the north and south of the canyon that rise steeply to form major ridgelines that define the lower Aliso Creek watershed; and rock outcrops and steep-walled rock faces that are found throughout the hillsides. Whereas the canyon floor and Aliso Creek have been heavily influenced by the historic and current uses, the steep hillsides and the rock outcrops and steep-walled rock faces remain relatively undisturbed within the study area. From its termination at the CTP the SOCWA force main is within an easement beneath the access road through the Laguna Beach Golf & Bungalow Village, LLC, (a golf course and resort, also known as "The Ranch") (Figure 2).

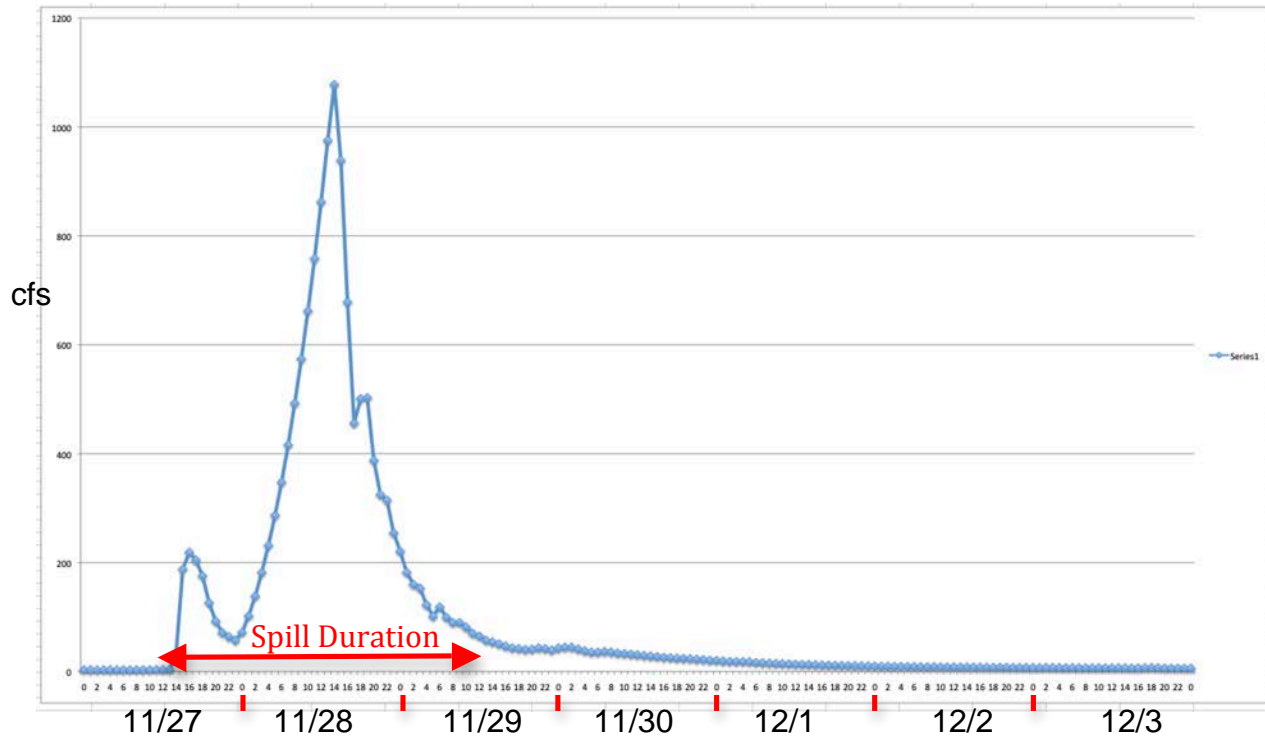
**Figure 3.** Aliso Creek average hourly stream discharge in cubic feet per second (cfs) before, during, and after the sewage release of November 27-29, 2019.

- During dry weather Aliso Creek normally has a stream discharge of approximately 3-6 cfs, however at the time of the spill the Aliso Creek drainage was experiencing a significant rain event and peak discharges of 222, 2073, and 234 cfs, were experienced on 11/27, 11/28, and 11/29, respectively.

Use of stream habitat during the spill event (11/27 and 11/28) by birds was greatly influenced by the intense rainfall and associated flood conditions (Figure 3). During reconnaissance biological surveys on 11/27 and 11/28 when rainfall was heavy, no birds or other animals were noted in incidental observations at any of the monitoring sites. Biologically each site is unique in stream characteristics, in-stream vegetation, riparian habitat, sun exposure, and many other factors and, therefore, are not strictly comparable. When the floodwaters began to subside, biological monitoring on 11/29 and the following days indicated bird use returning to normal. Fast flowing, narrow upstream and downstream sites with riparian vegetation were dominated by upland

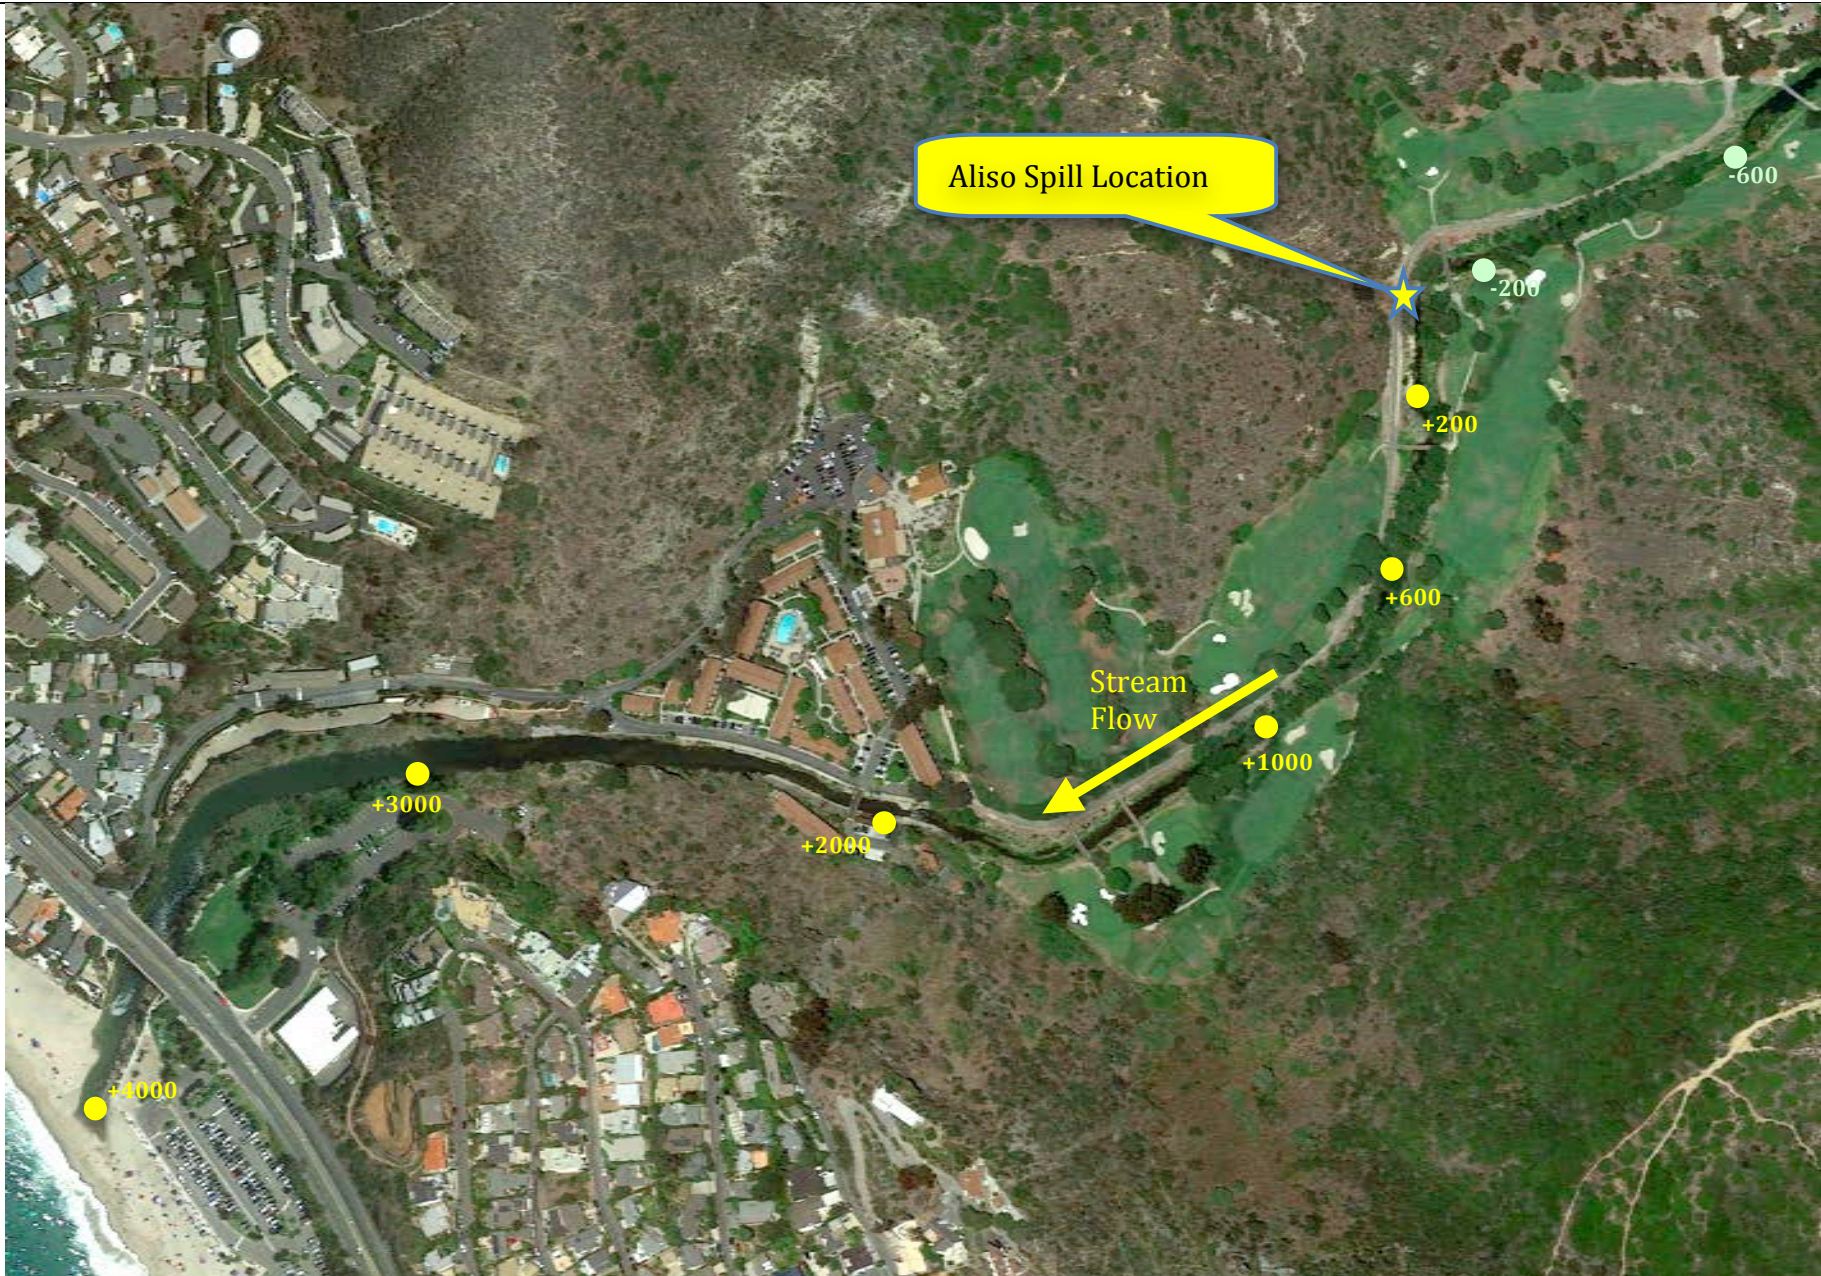
**Figure 4.** Biological assessment monitoring sites: two upstream control sites, the spill site, and six downstream impact survey sites.

- -600 feet: Site located 600 feet upstream from the spill site as a control to establish background stream conditions.
- -200 feet: Site located 200 feet upstream from the spill site as a control to further establish background stream conditions.

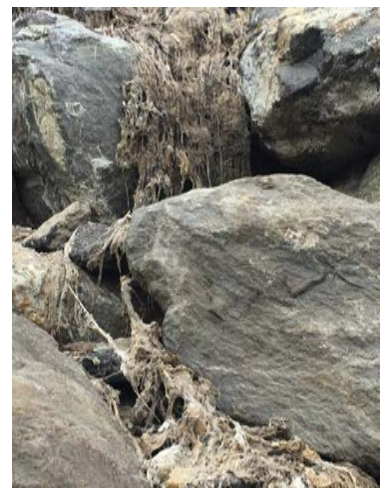
**Figure 5.** Organic matter on riprap at the spill site.

The stream bank substrate, water edge and riparian vegetation were examined for the presence of organic matter. The riprap at the spill site was closely examined on 12/3/2019, three days after the spill was terminated. Filaments of accumulated dry organic matter were noted on the riprap leading down to the stream edge (Figure 5). When examined on 12/3/2019, there was no odor associated with the organic material. Although a large volume of organic matter was undoubtedly released with the sewage spill, the stream discharge was so high throughout the spill that organic matter did not collect and was not detected at any downstream site.

- **Organic Matter.** The riprap at the spill site was closely examined on 12/3, three days after the spill was terminated. Filaments of accumulated dry organic matter were noted on the riprap leading down to the stream edge. Although a large volume of organic matter was undoubtedly released with the sewage spill, the stream discharges were so high throughout the spill that organic matter did not collect and was not detected at any downstream site.

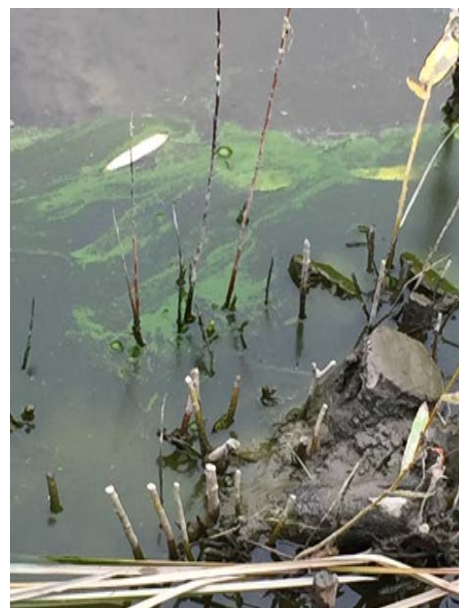
**Figure 6.** Algae bloom at upstream site -600.

An algae bloom was observed at an upstream control site on 12/3/2019 (Site -600; Figure 6). Stream discharge was low at about 6.5 cfs and algae were observed to be accumulating in the backwater areas of the stream at Site -600. No other sites exhibited algae growth/bloom and the algae bloom observed at upstream Site -600 is unrelated to the spill event.

- **Algae Growth/Bloom.** An algae bloom was observed at an upstream control site on 12/3 (Site -600). Stream discharge was low at about 6.5 cfs and algae were observed to be accumulating in the backwater areas of the stream at Site -600. No other sites exhibited algae growth/bloom and the algae bloom observed at upstream Site -600 is unrelated to the spill event.

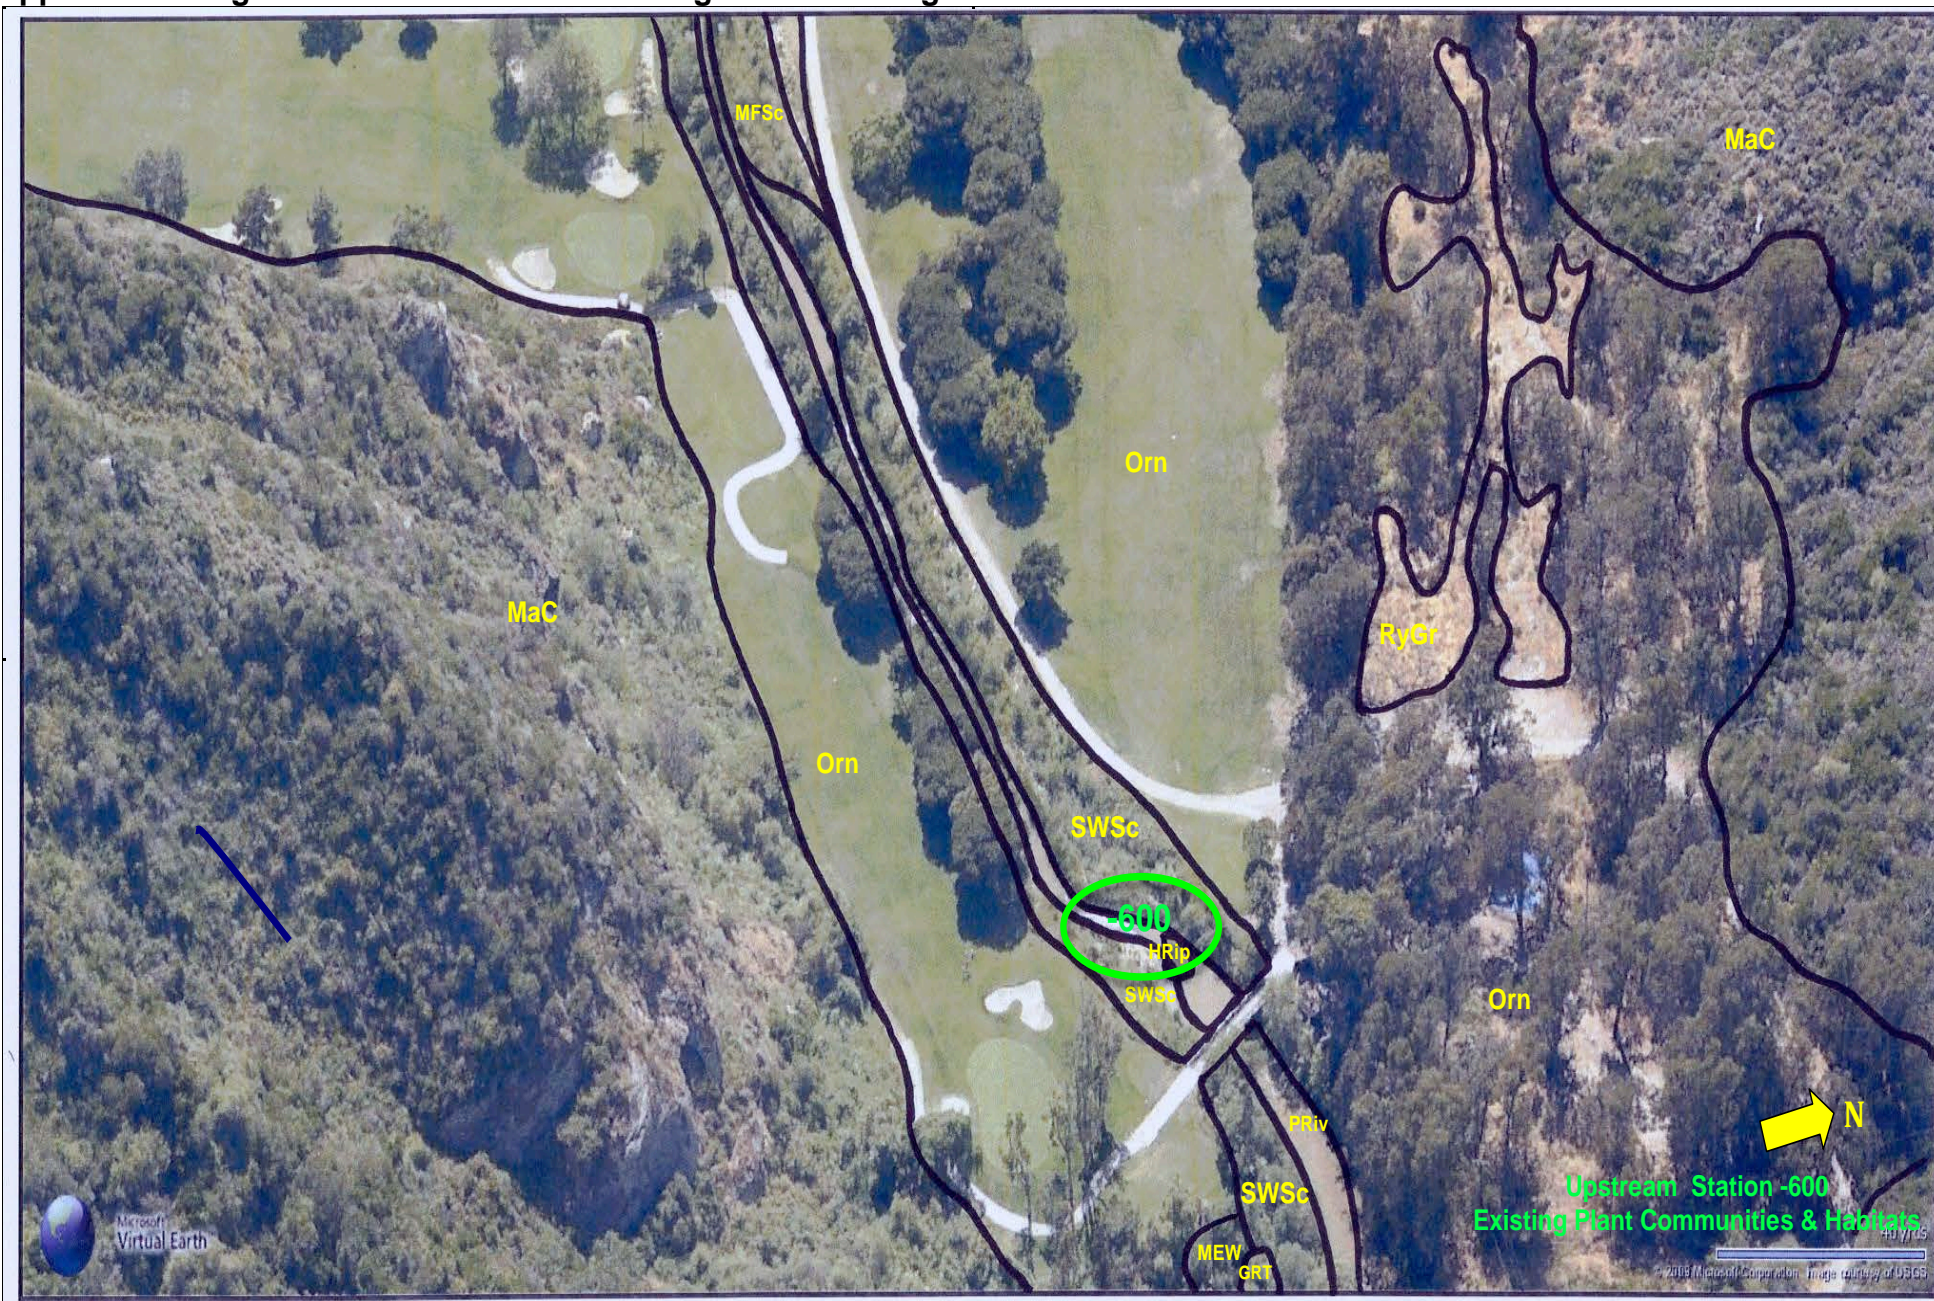
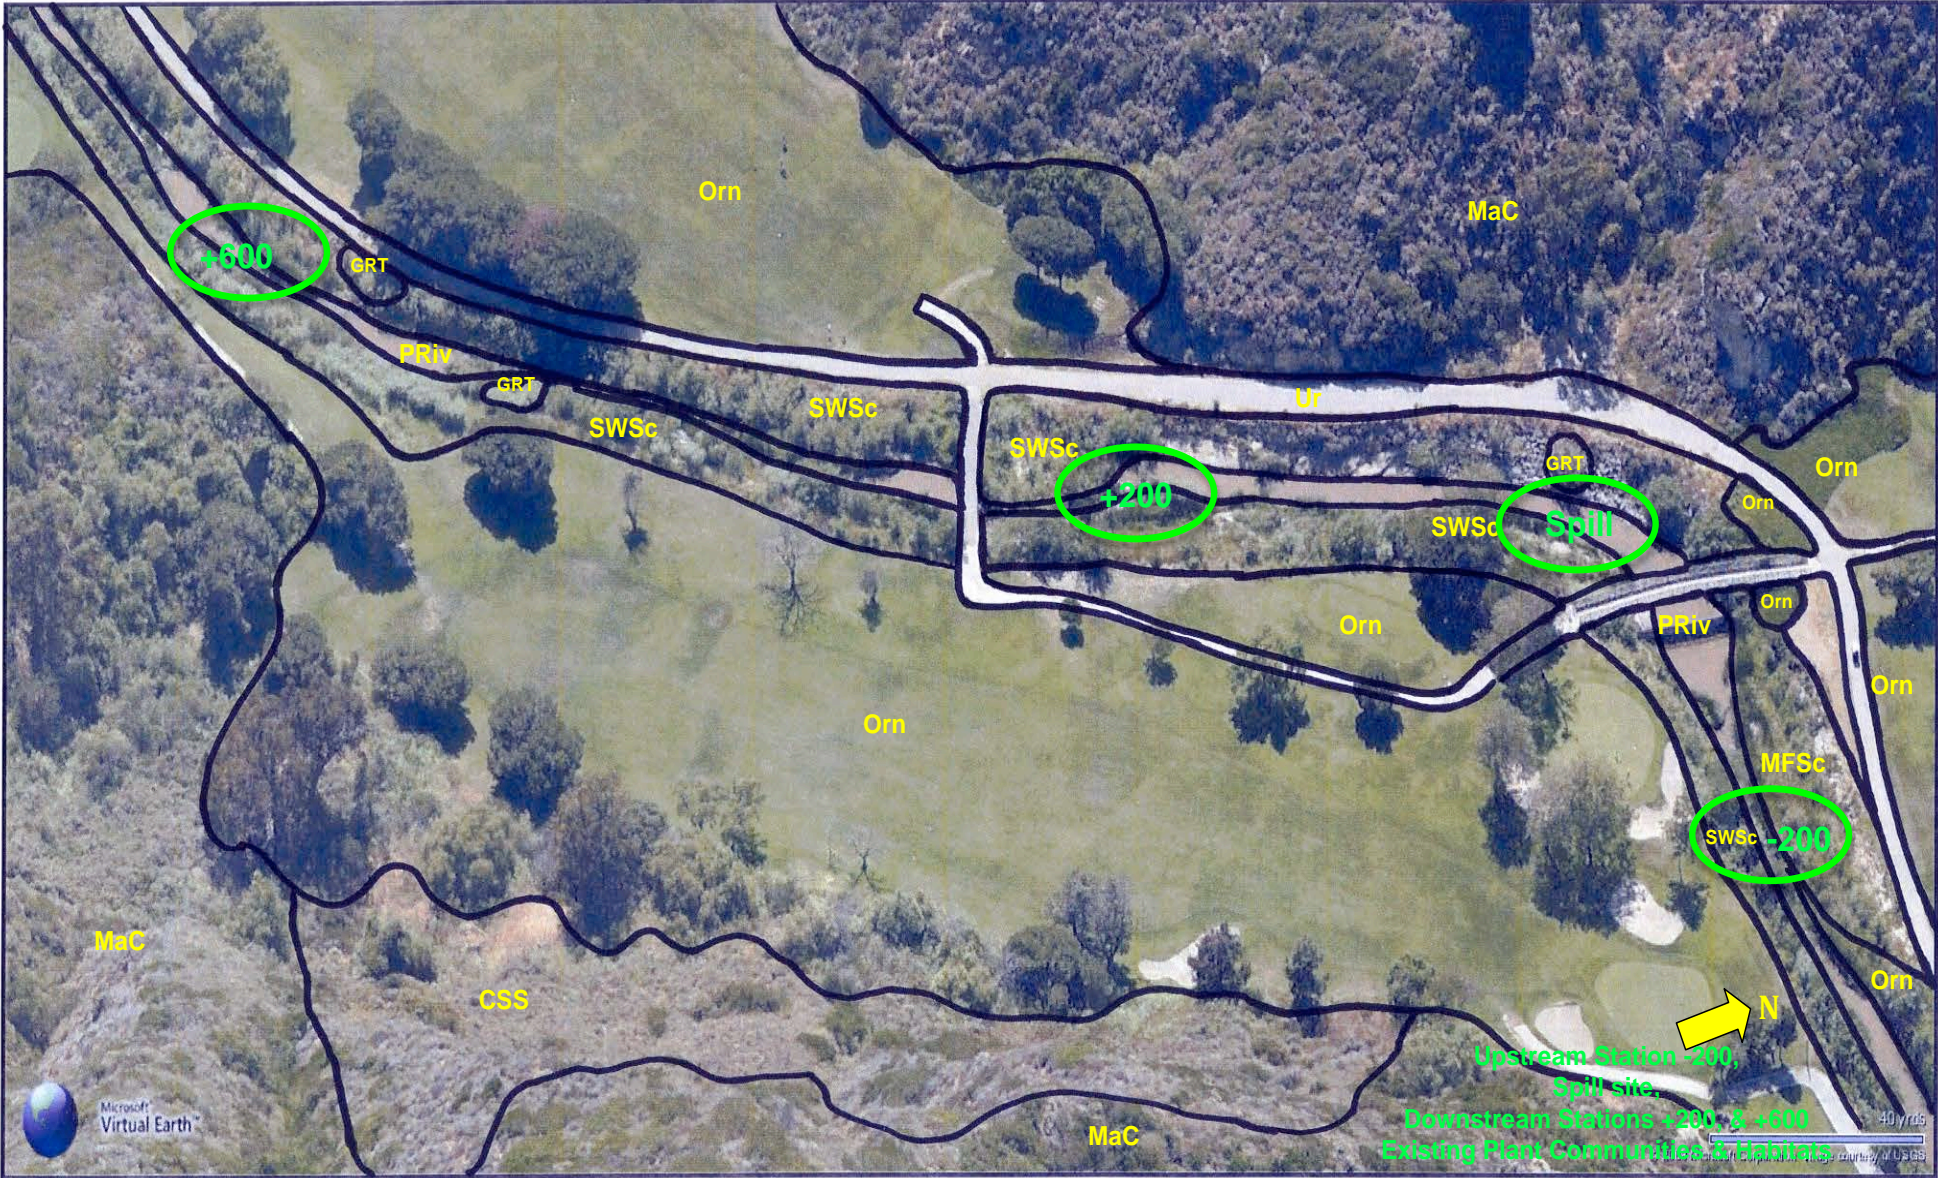
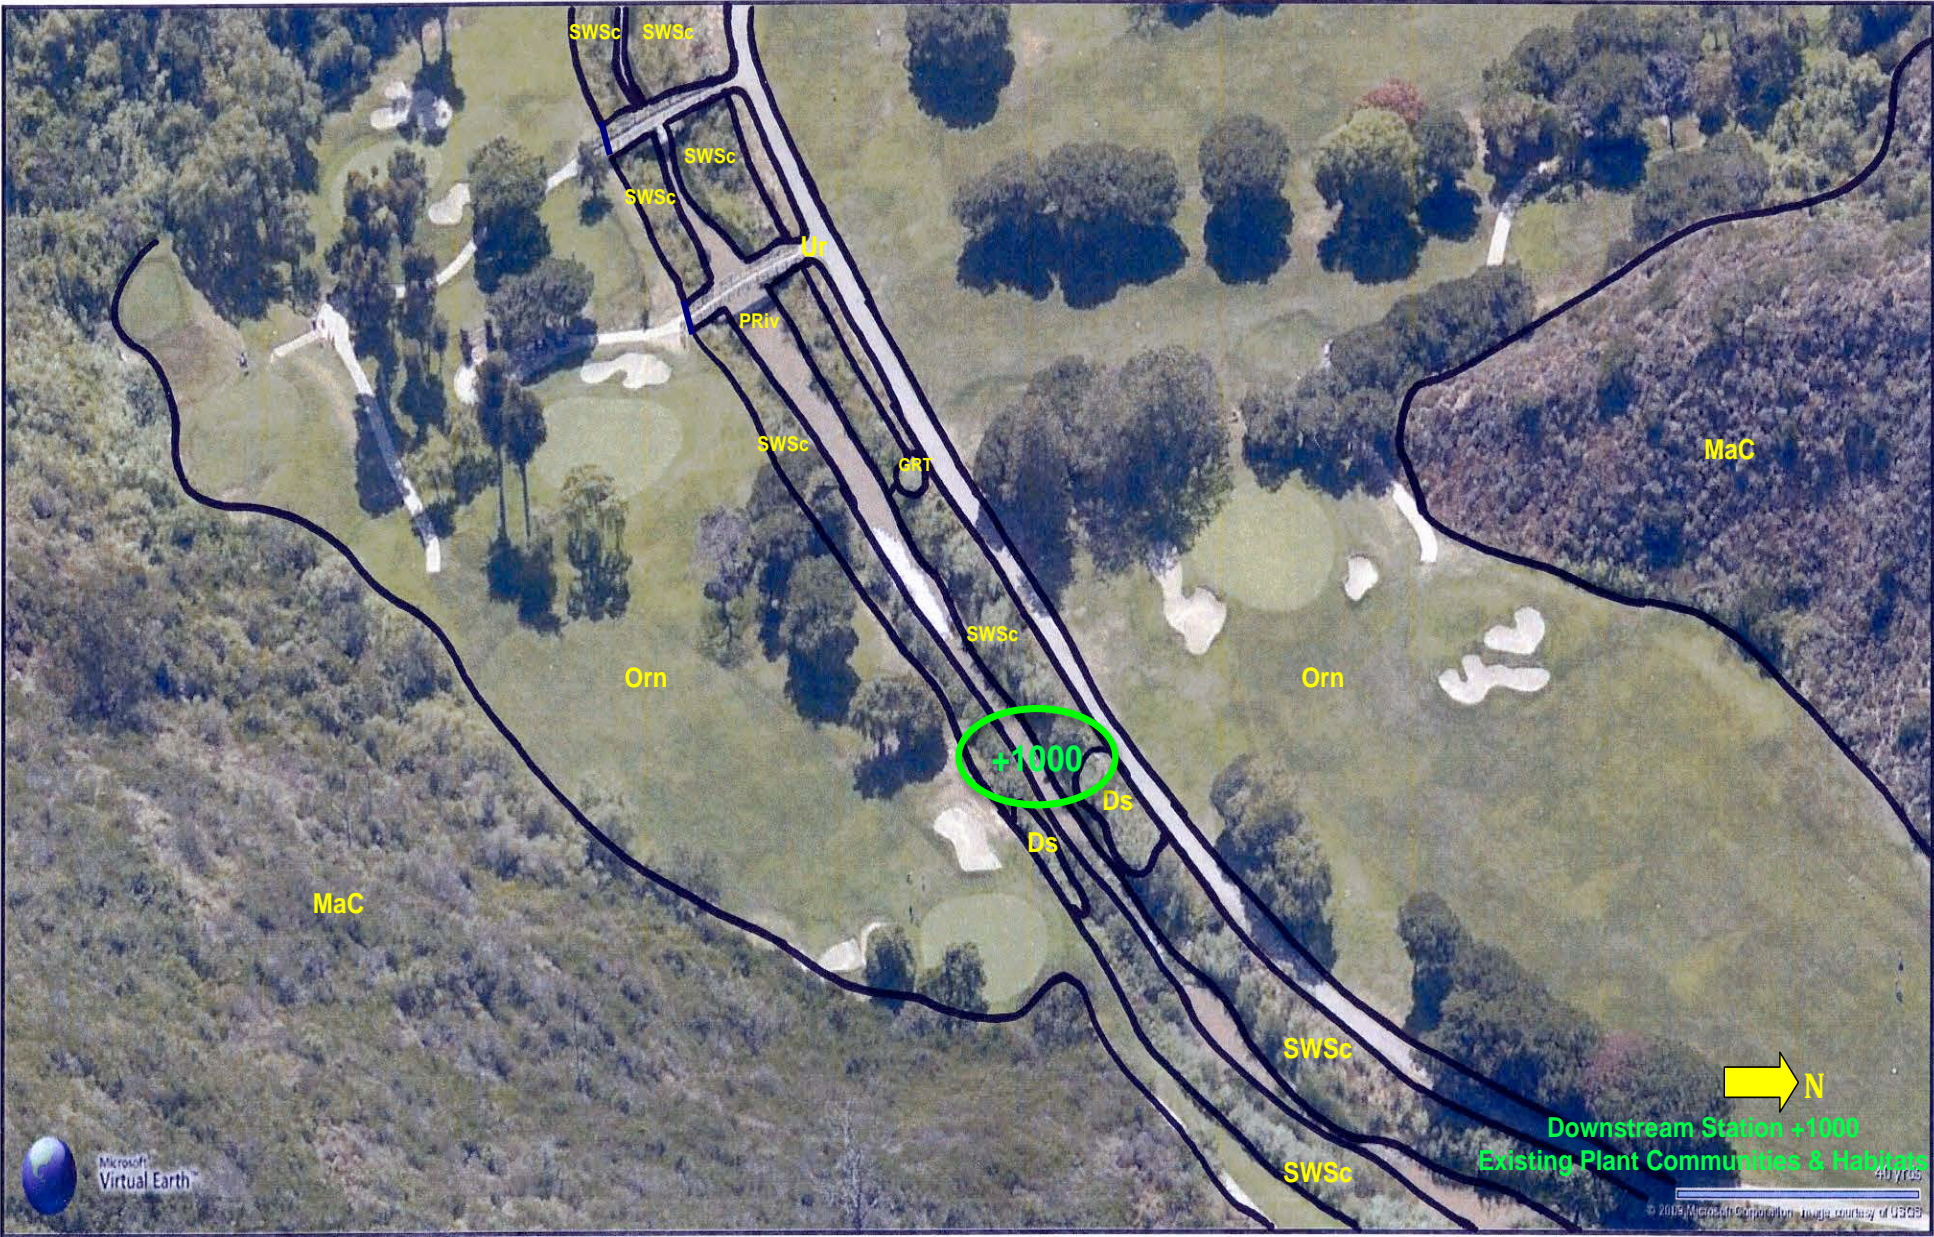
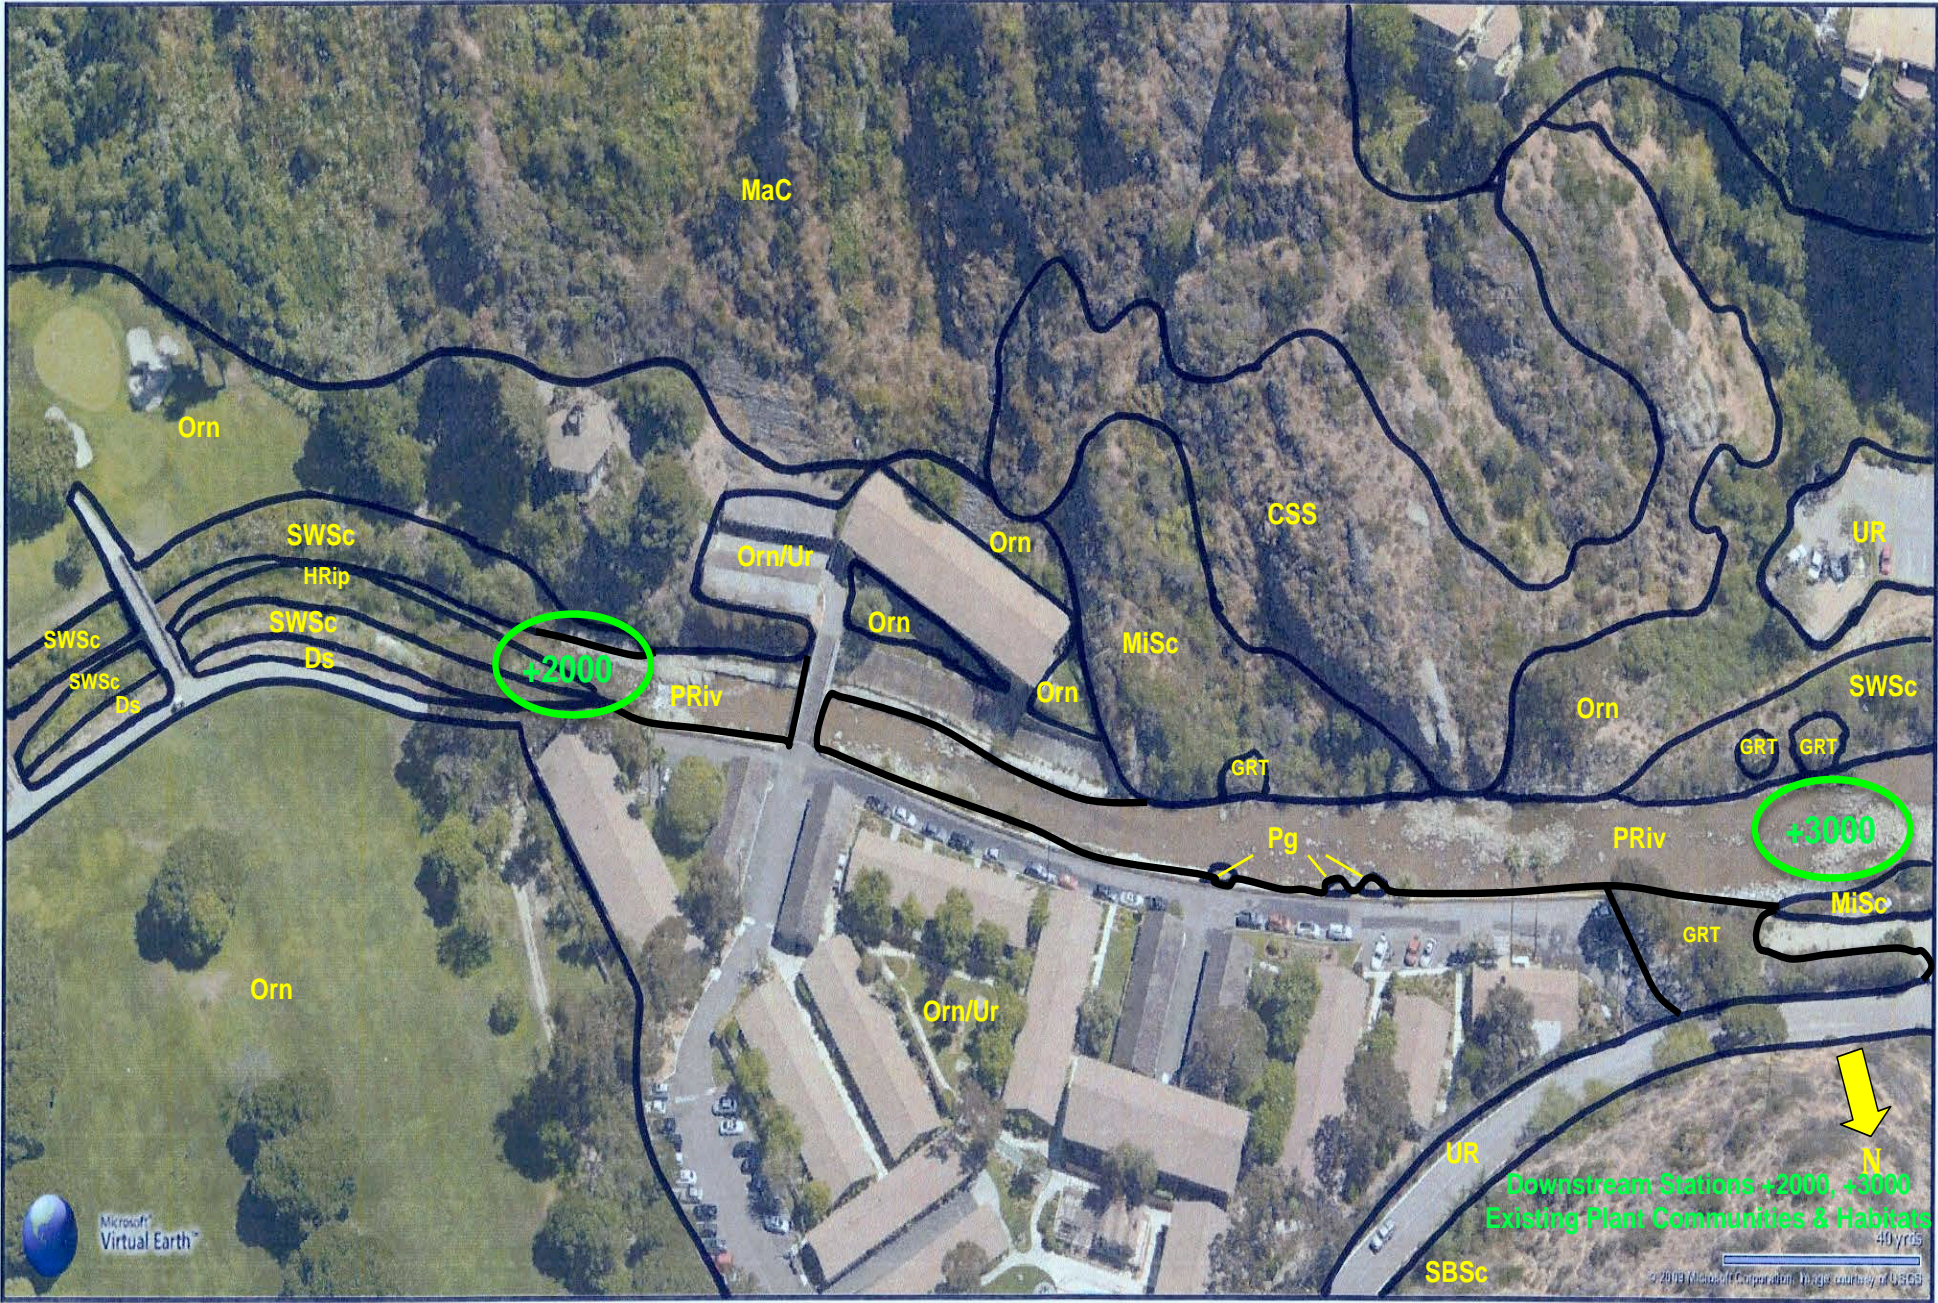
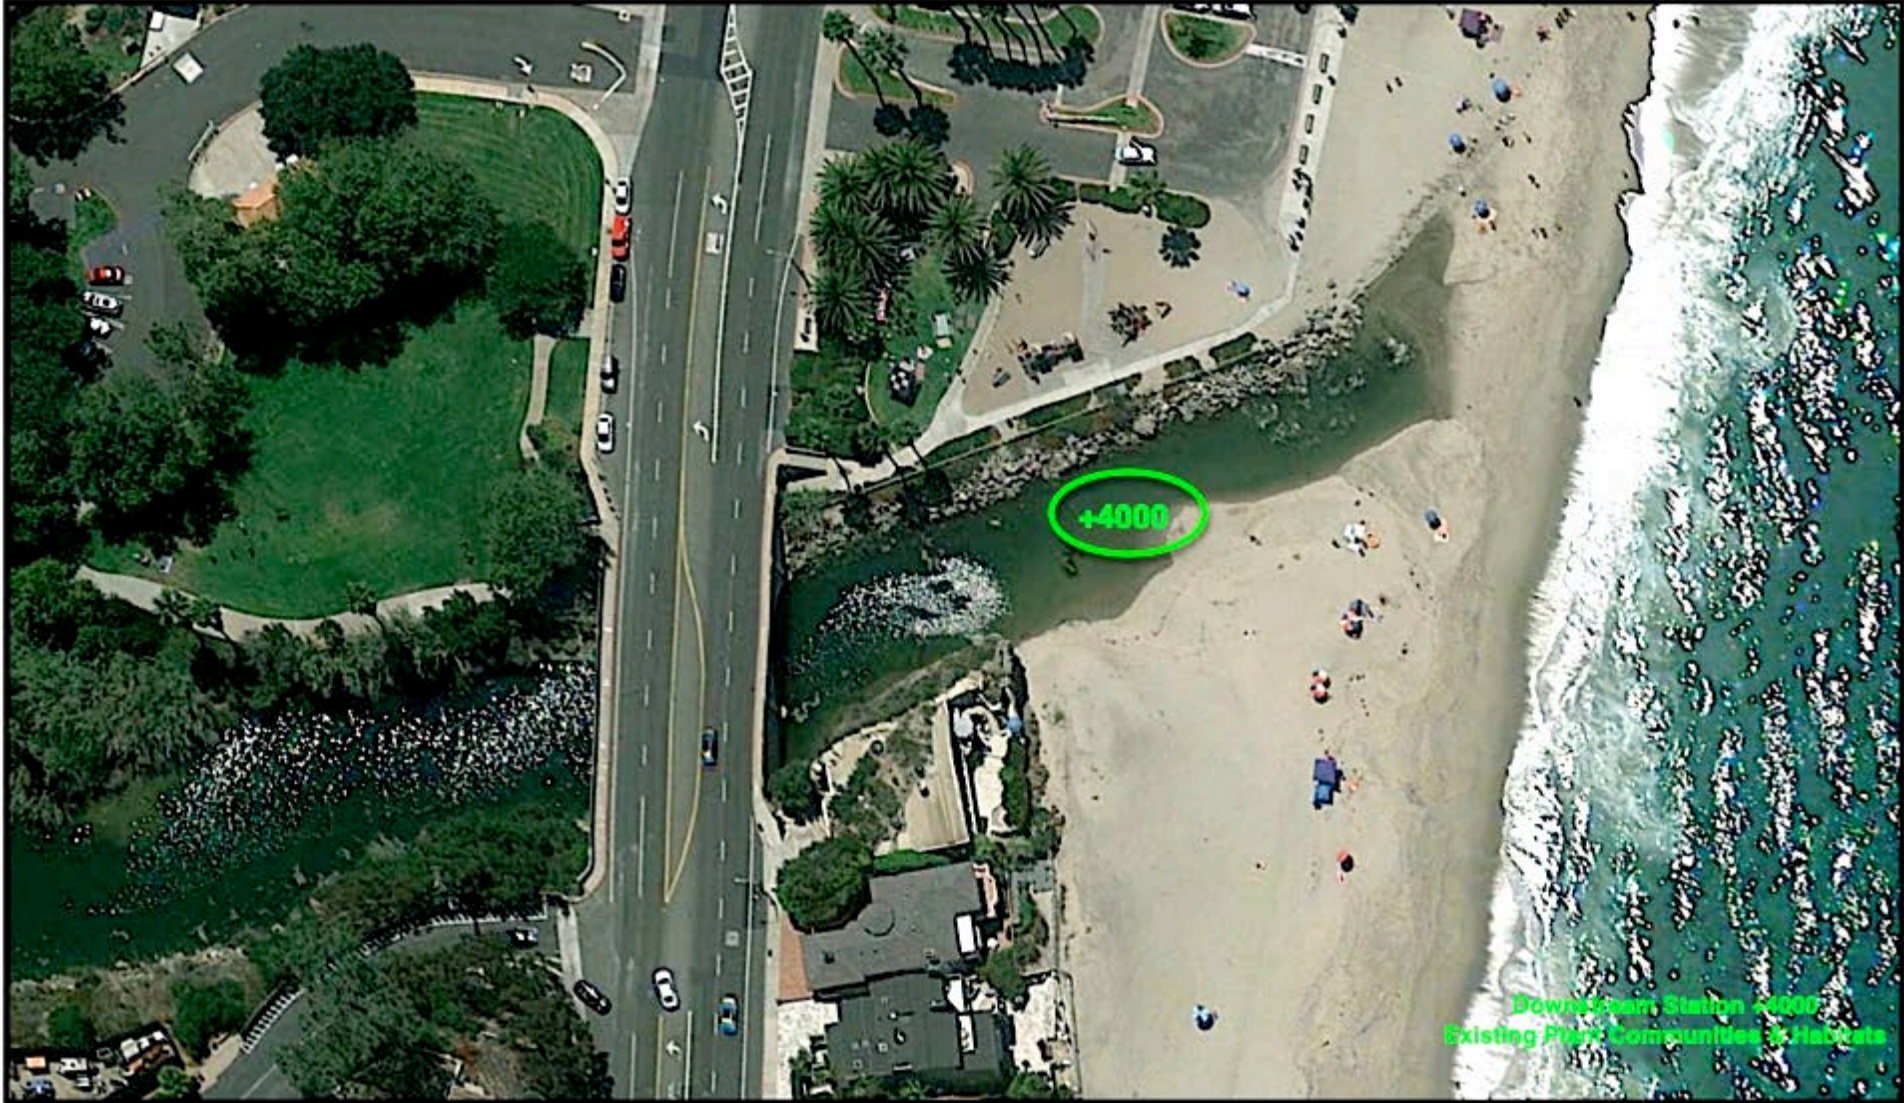
Appendix B. Vegetation Communities at Biological Monitoring Sites in Aliso Creek

Vegetation maps of the monitoring sites within the spill study area are provided in Appendix B (adopted from PRC 2009). Upstream of the spill study area Aliso Creek has relatively natural streambed conditions with relatively thick riparian habitat dominated by southern willow scrub and mule fat scrub. The downstream section of Aliso Creek within The Ranch has been channelized and riparian habitat along this section is comprised of a narrow band of southern willow scrub and mule fat scrub with some bank areas consisting of bare soil, riprap, or concrete channel. Beyond this narrow band of riparian habitat the vegetation is primarily ornamental (golf course) or urban development as part of the resort complex. The vegetation and habitat communities within the spill study area include the following (PRC 2007; communities after Holland, 1986):

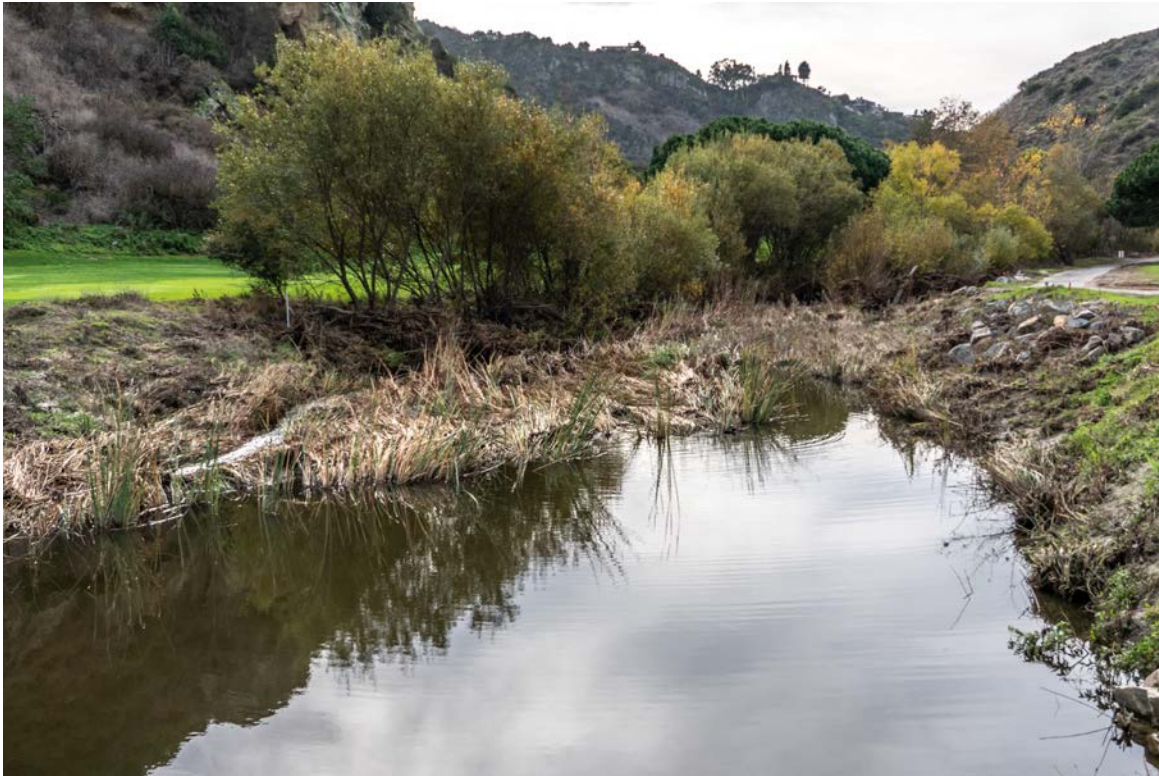
Upstream Site -600, view downstream: December 10, 2019; Stream discharge = 6.5 cfs

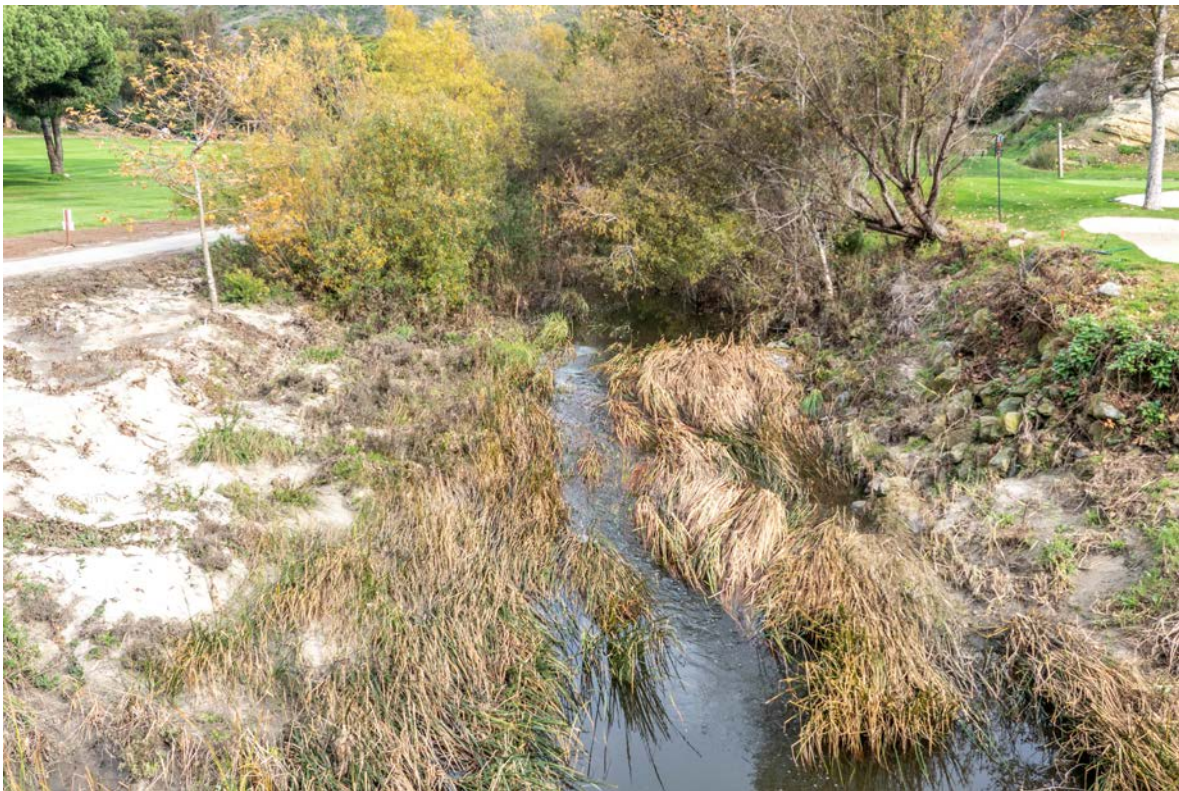
Upstream Site -200, view upstream: December 10, 2019; Stream discharge = 6.5 cfs

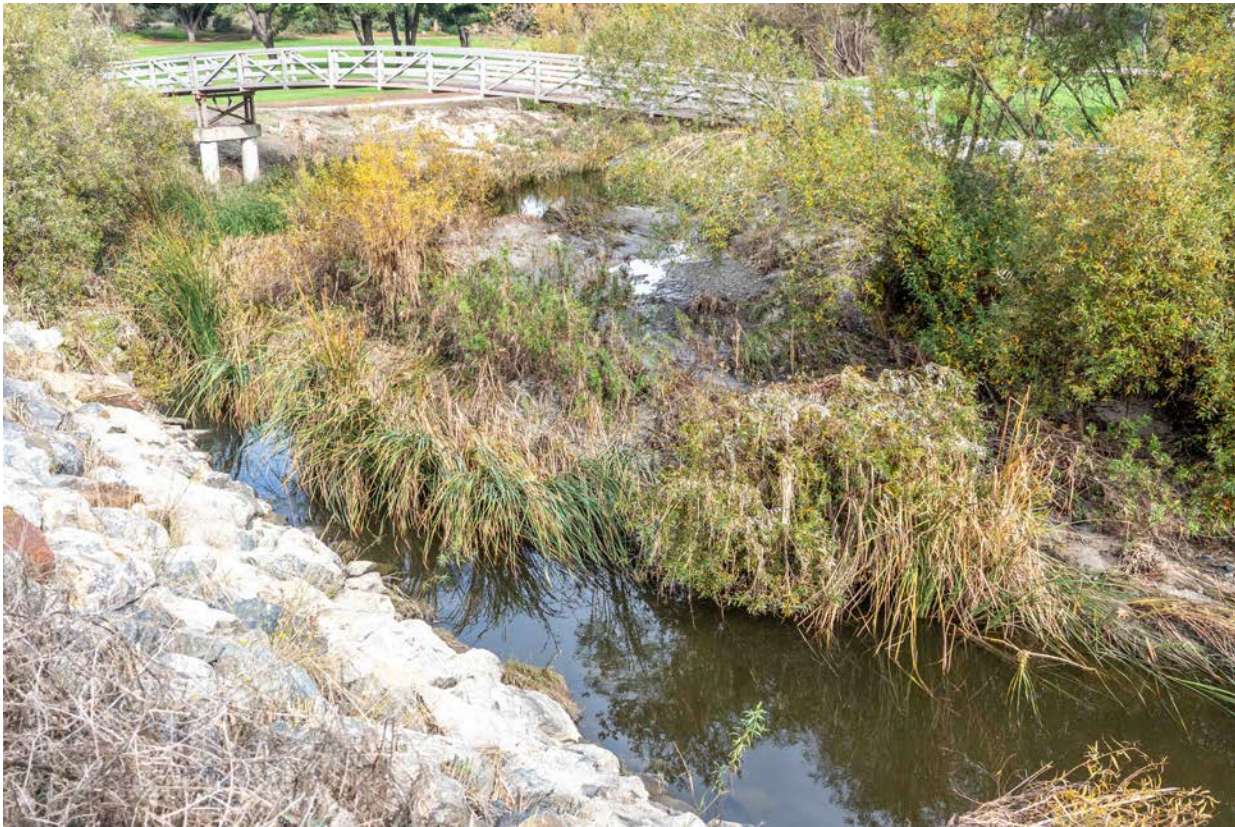
Spill Site, view upstream: December 10, 2019; Stream discharge = 6.5 cfs
