South Orange County Wastewater Authority  
34156 Del Obispo Street  
Dana Point, CA 92629

**Biological Resources Damage Assessment  
for the  
North Coast Interceptor Force Main Spill  
of  
November 27-29, 2019**

**Dwight Mudry, Ph.D.  
Environmental & GIS Services, LLC**

**January 2020**

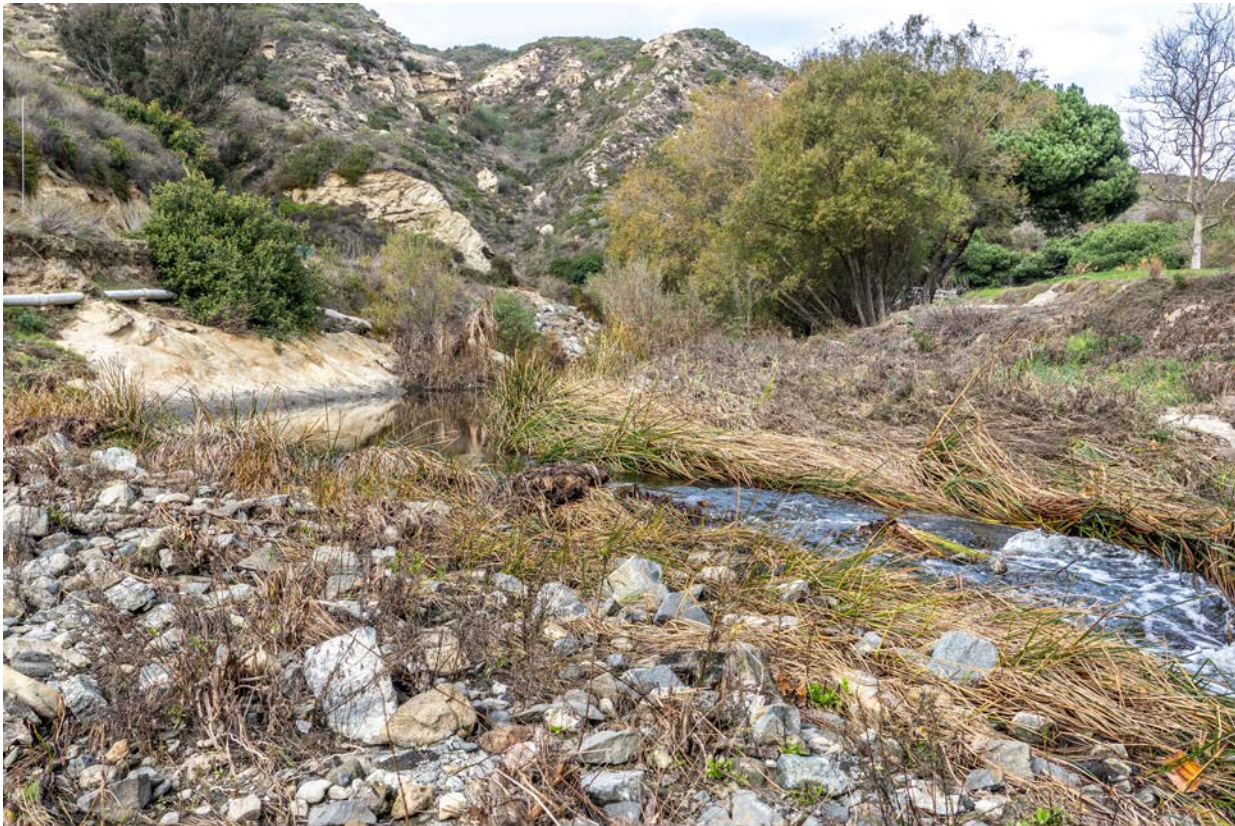
Downstream Site +200, view upstream: December 10, 2019; Stream discharge = 6.5 cfs

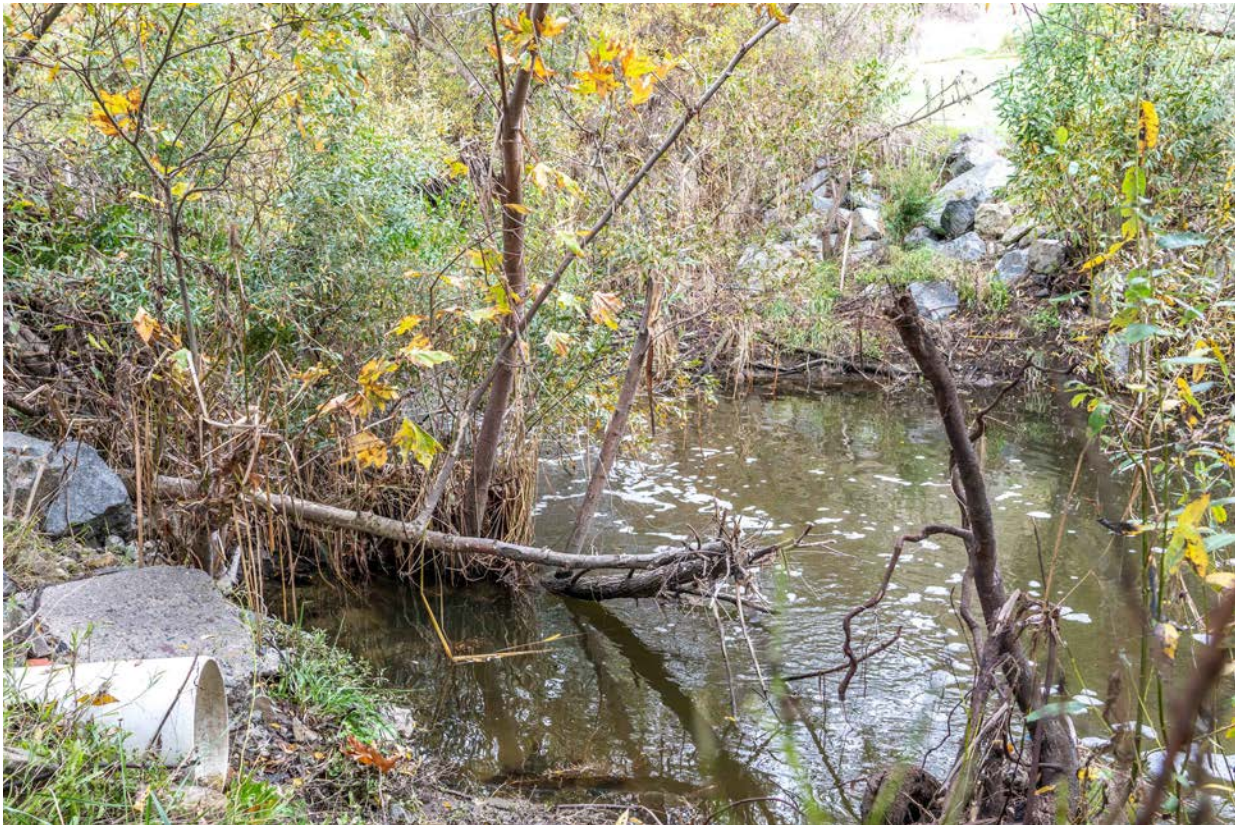
Downstream Site +600, view upstream: December 10, 2019; Stream discharge = 6.5 cfs

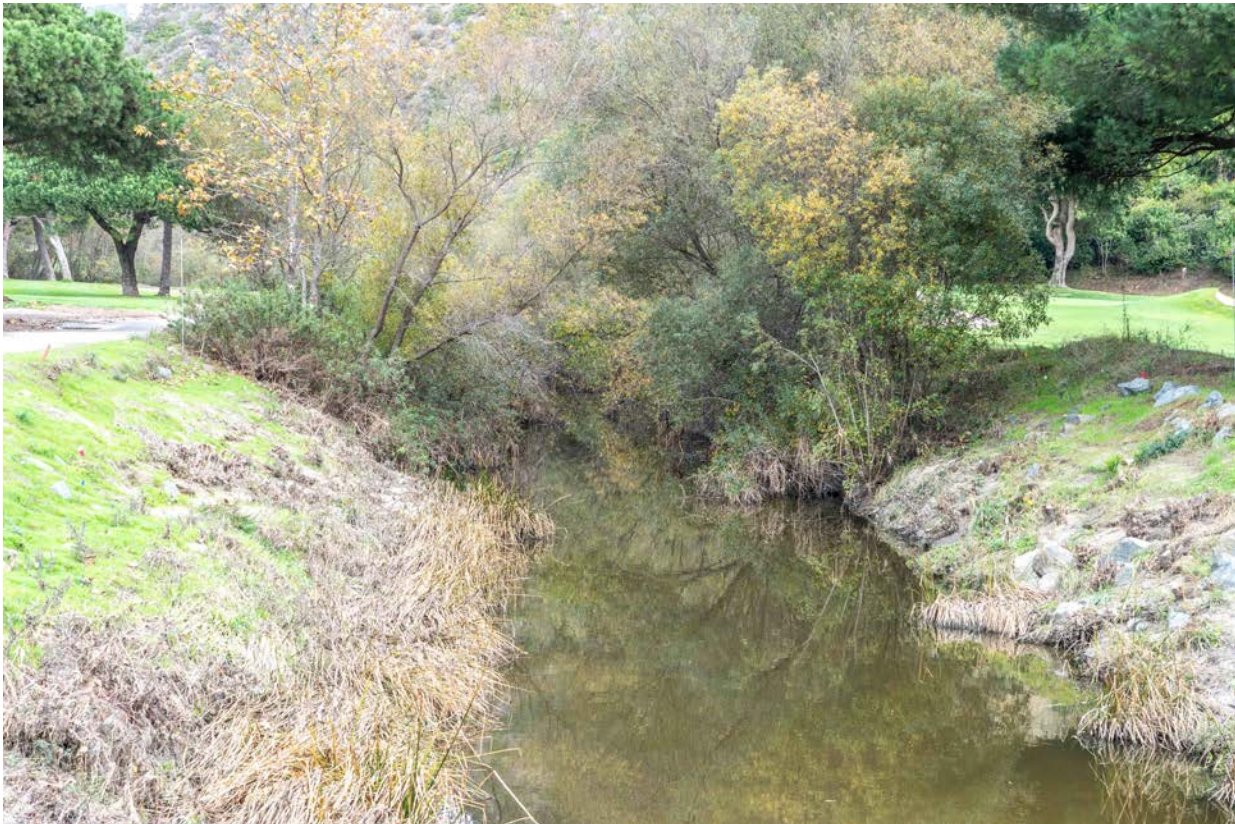
Downstream Site +1000, view upstream: December 10, 2019; Stream discharge =6.5 cfs

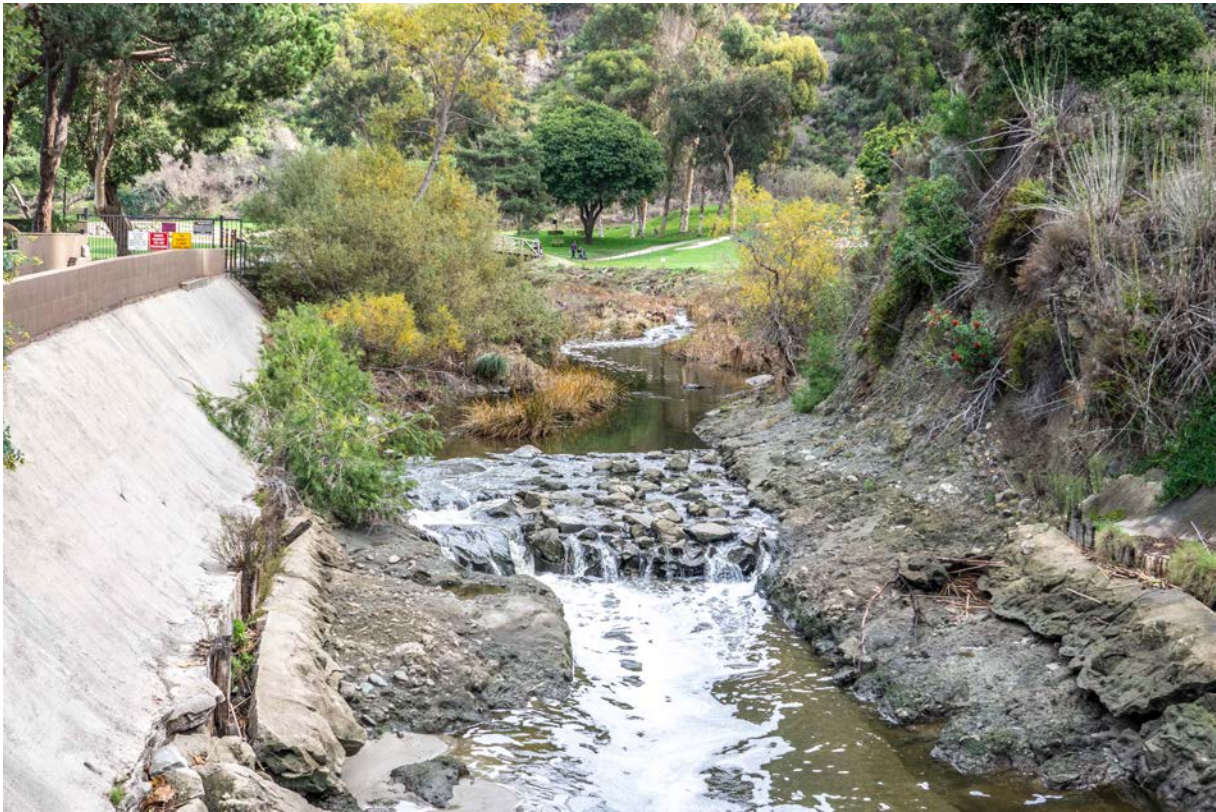
Downstream Site +2000, view upstream: December 10, 2019; Stream discharge =6.5 cfs

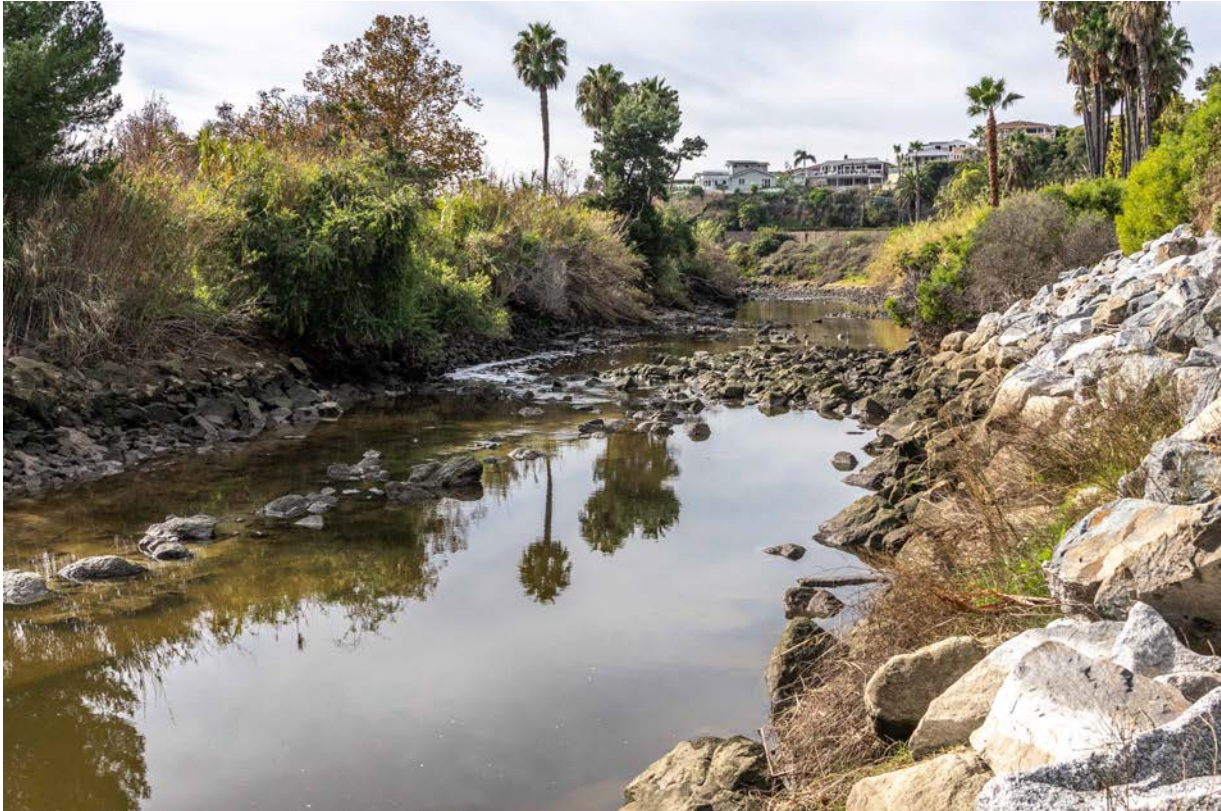
Downstream Site +3000, view downstream: December 10, 2019; Stream discharge =6.5 cfs

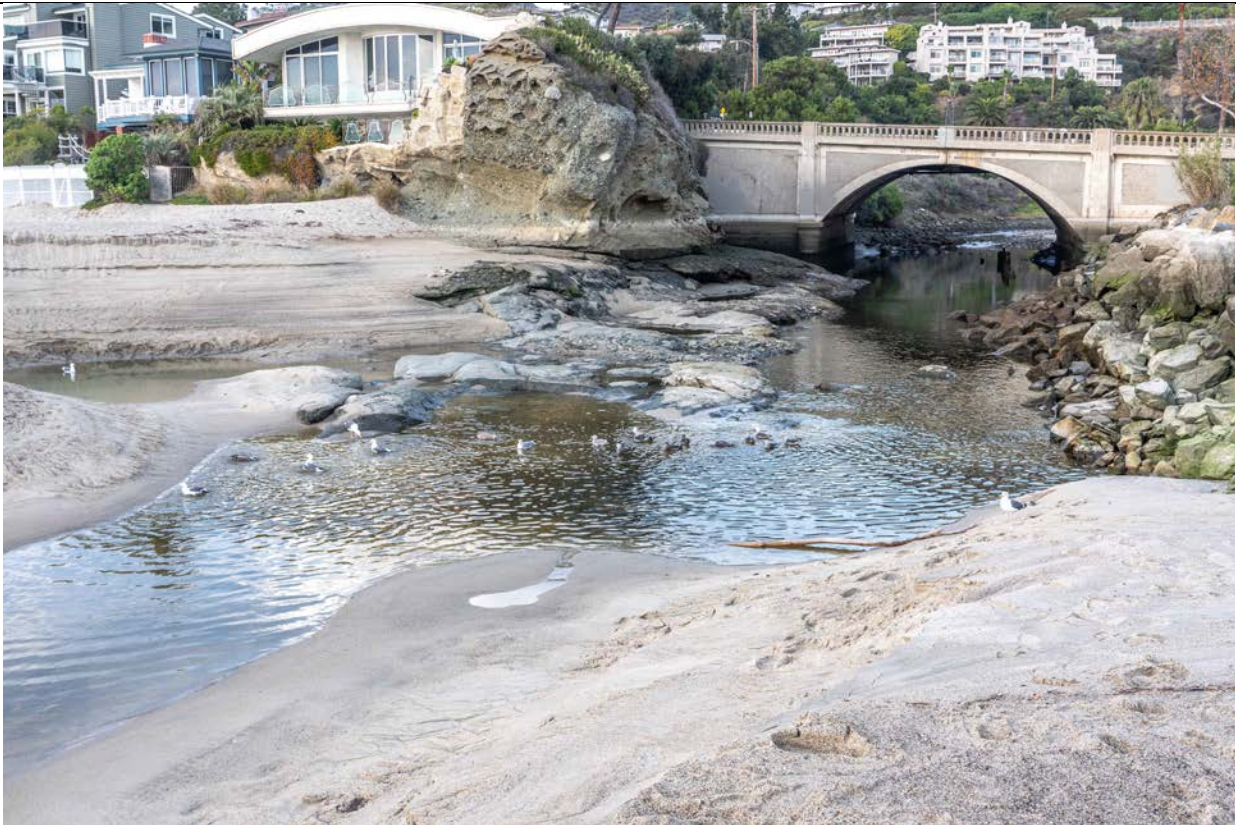
Downstream Site +4000, view upstream: December 10, 2019; Stream discharge = 6.5 cfs
