ASSESSMENT OF SEWER LIFT STATIONS AND NORTH COAST INTERCEPTOR

APRIL 2003

City of Laguna Beach

Boyle Engineering Corporation

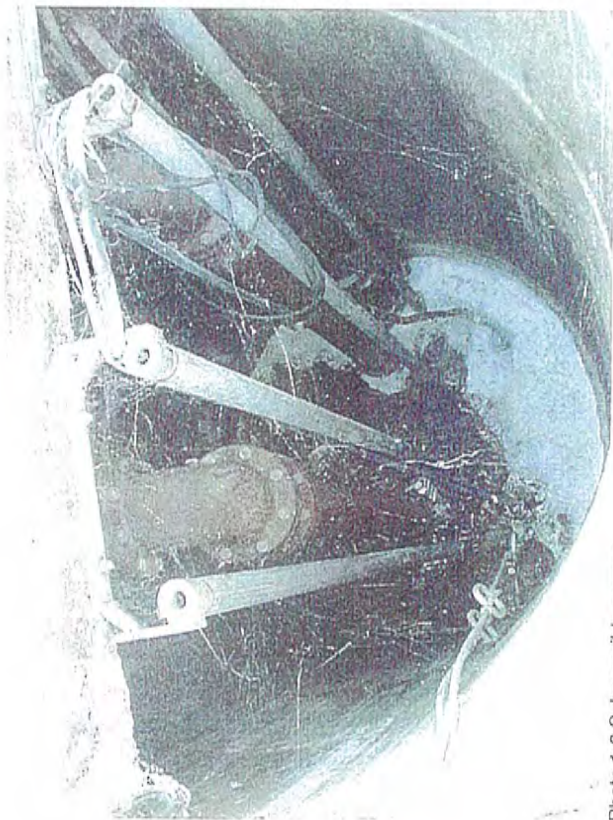
Photo 1-2 Submersible pumps
MVC-170F50.JPG
12/18/2002 (Wed), 3:12 PM

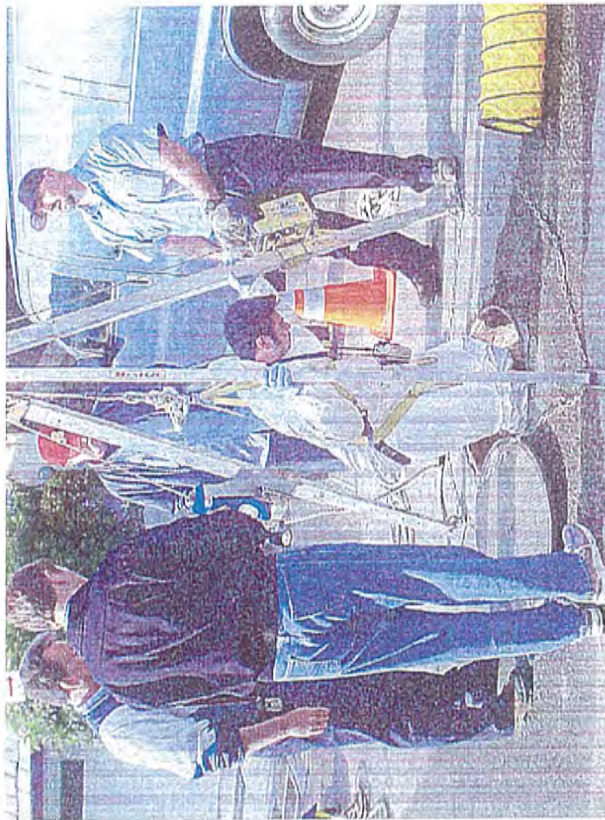
Photo 2-2 Wet Well Entry
Photo2-2.jpg
03/14/2003 (Fri), 8:48 AM

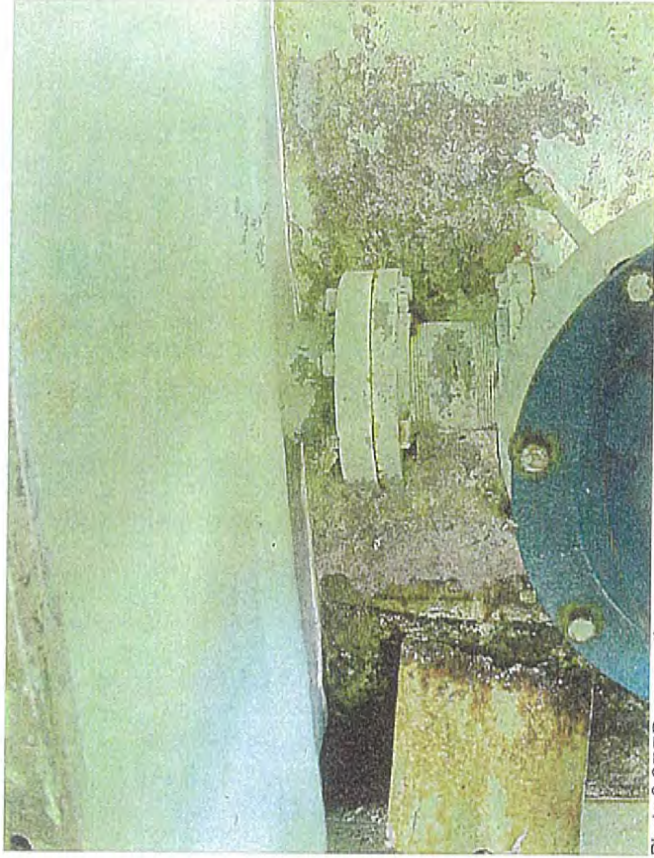
Photo 3-2 Pump suction connection to tank; no valve
12/18/2002 (Wed), 2:31 PM

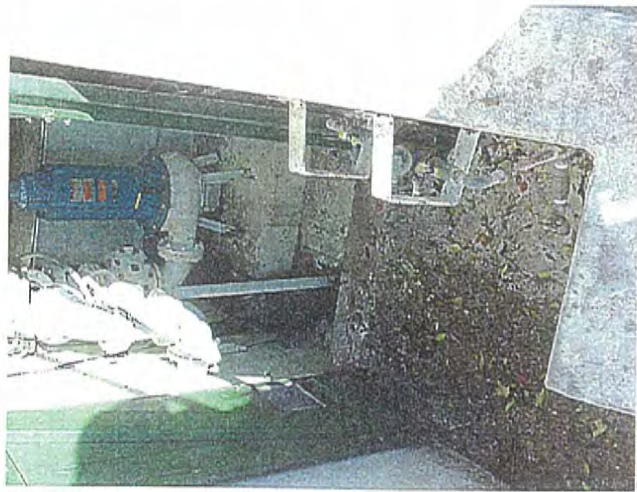
Photo 3-3 Station entry
12/18/2002 (Wed), 2:33 PM

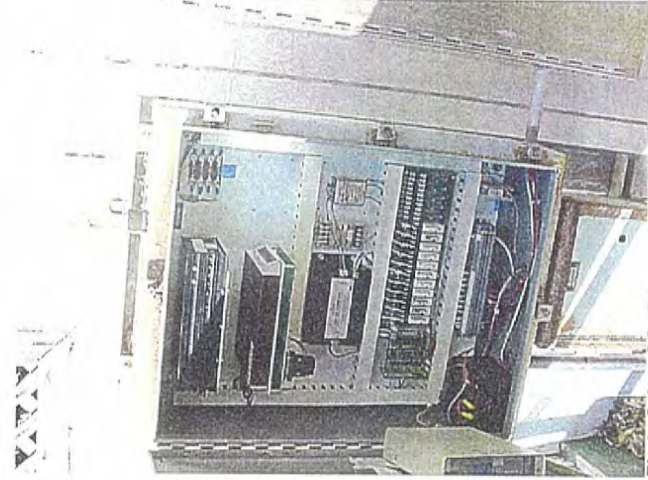
Photo 3-4 SCADA panel
12/18/2002 (Wed), 2:34 PM

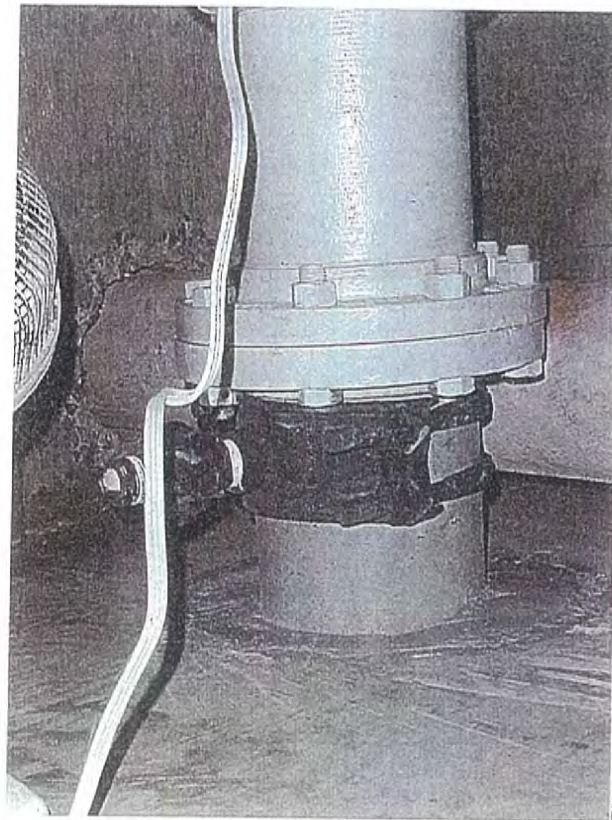
Photo 6-4 Service clamp on station discharge header
MVC-156F.JPG
12/18/2002 (Wed), 1:32 PM

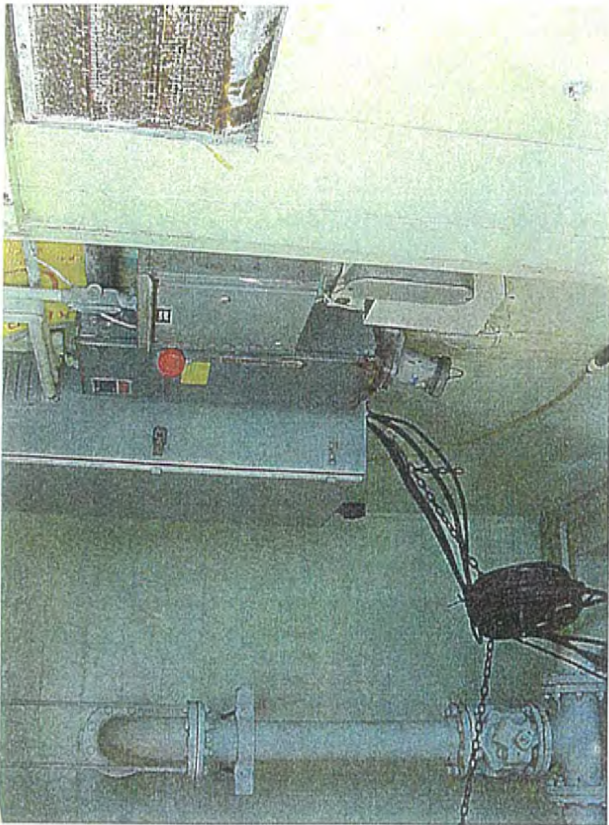
Photo 7-1 Electrical cabinets and dischrg line
MVC-143F.JPG
12/18/2002 (Wed), 11:50 AM

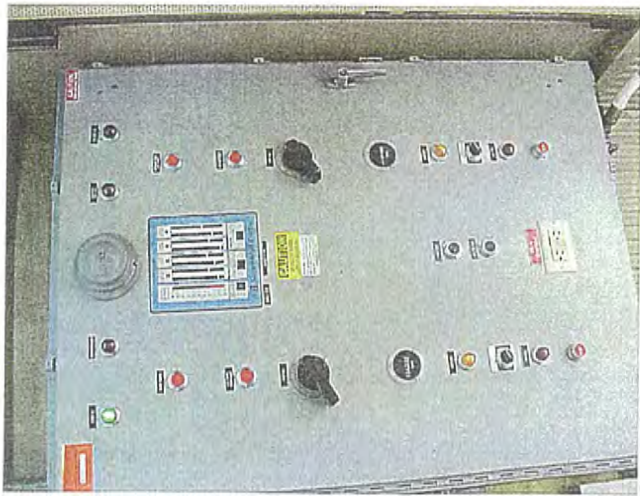
Photo 8-1 Control panel
12/18/2002 (Wed), 12:47 PM

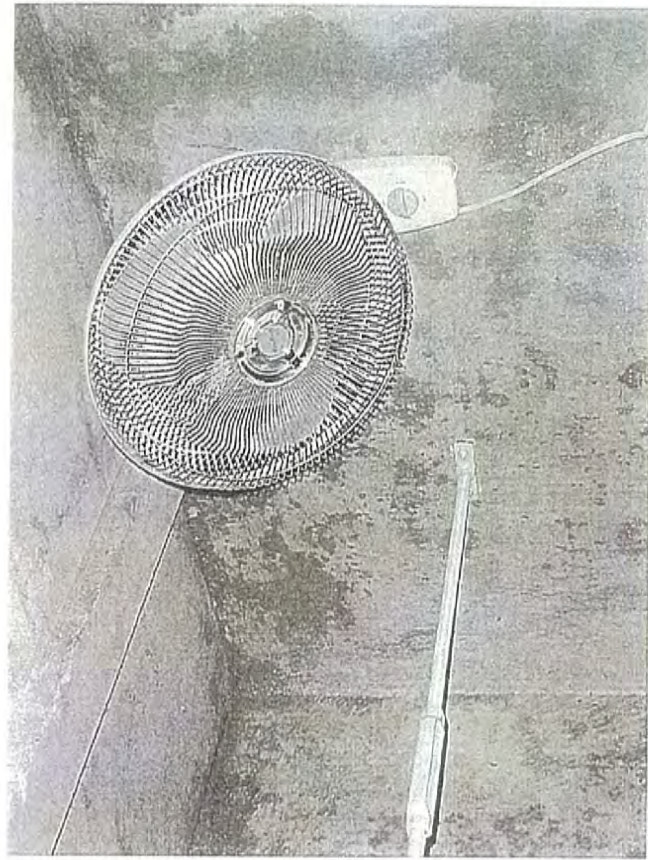
Photo 8-2 Fan for heat dissipation
12/18/2002 (Wed), 12:51 PM

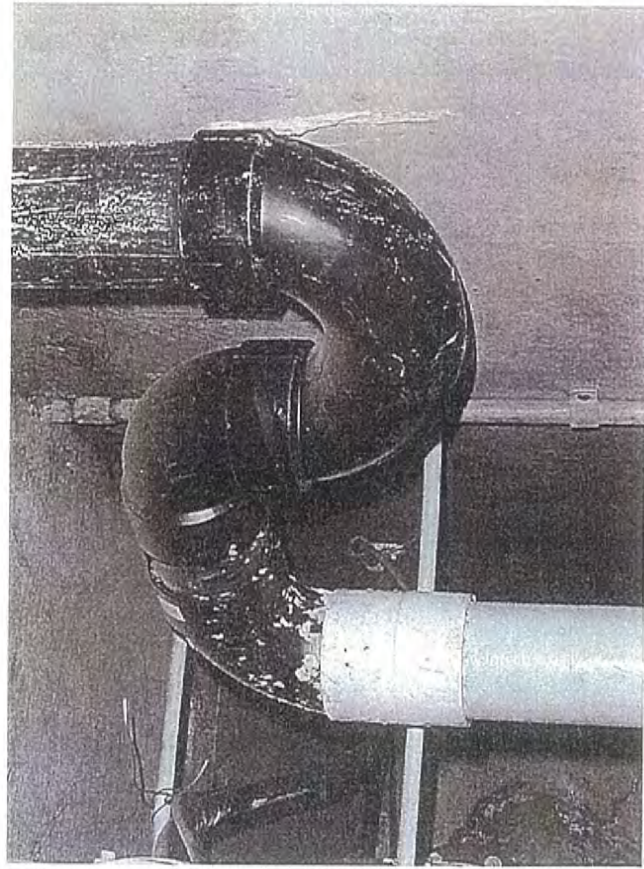
Photo 8-3 Wet well overflow piping
12/18/2002 (Wed), 12:52 PM

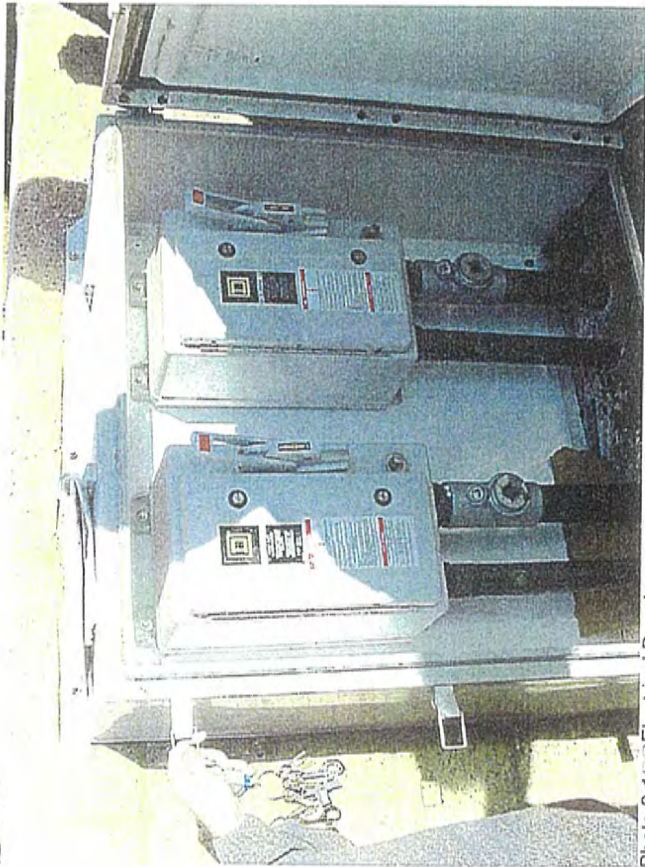
Photo 9-1: Electrical Panels
12/18/2002 (Wed), 3:28 PM

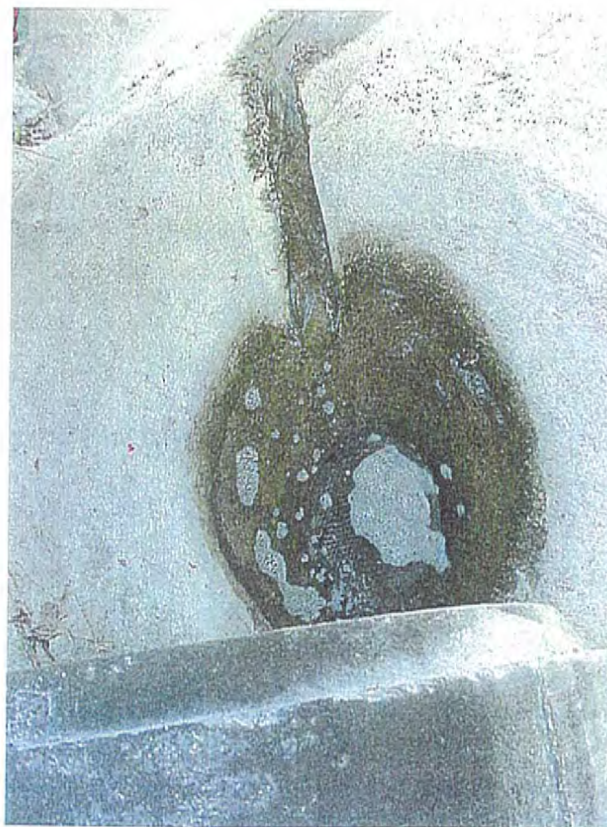
Photo 13-511 Minor storm drain flow. In Summer, plate is replaced with grate for diversion to wet we
MVC-139F.JPG
12/18/2002 (Wed), 11:20 AM

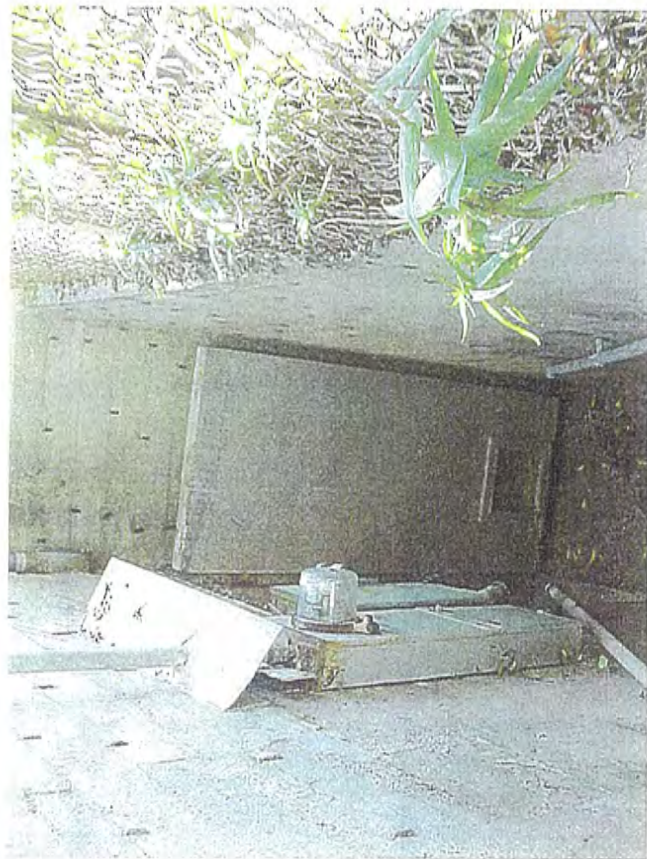
Photo 16-2: Stairway and entry. Electrical panel and station are subject flooding
12/18/2002 (Wed), 10:26 AM

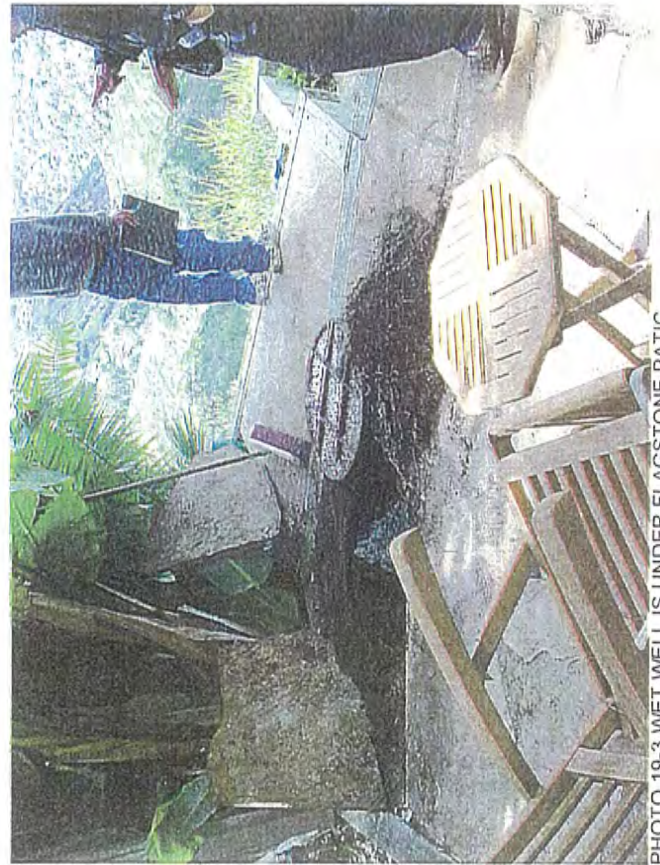
PHOTO 19-3 WET WELL IS UNDER FLAGSTONE PATIO
12/24/2002 (Tue), 11:50 AM

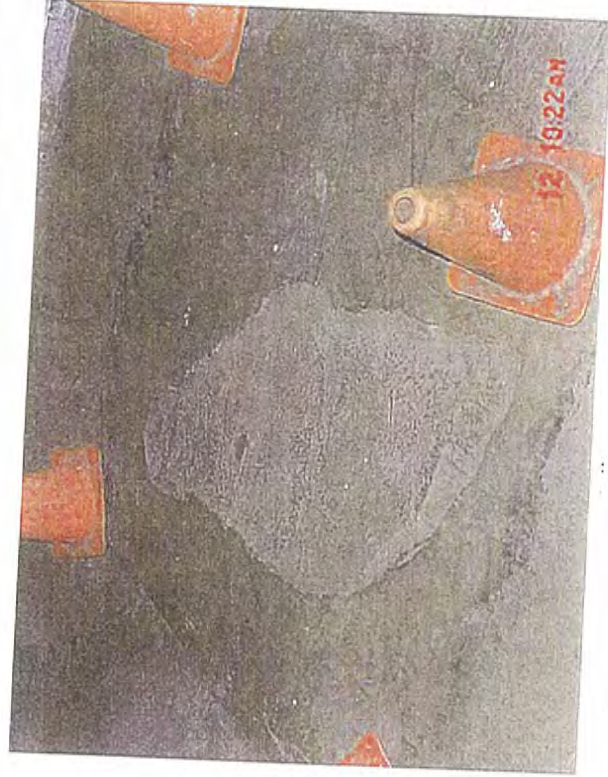
Photo 25-22 Pump Room Floor
LagunaBeach6.jpg
12/12/2002 (Thu), 1:44 PM

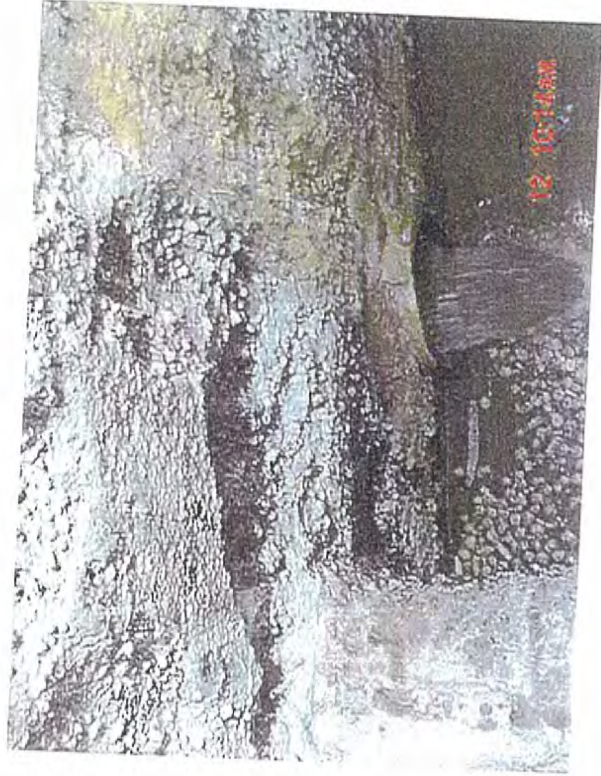
Photo 25-24 WET WELL INFLOW
LagunaBeachLiftStationInlet.jpg
12/12/2002 (Thu), 1:09 PM

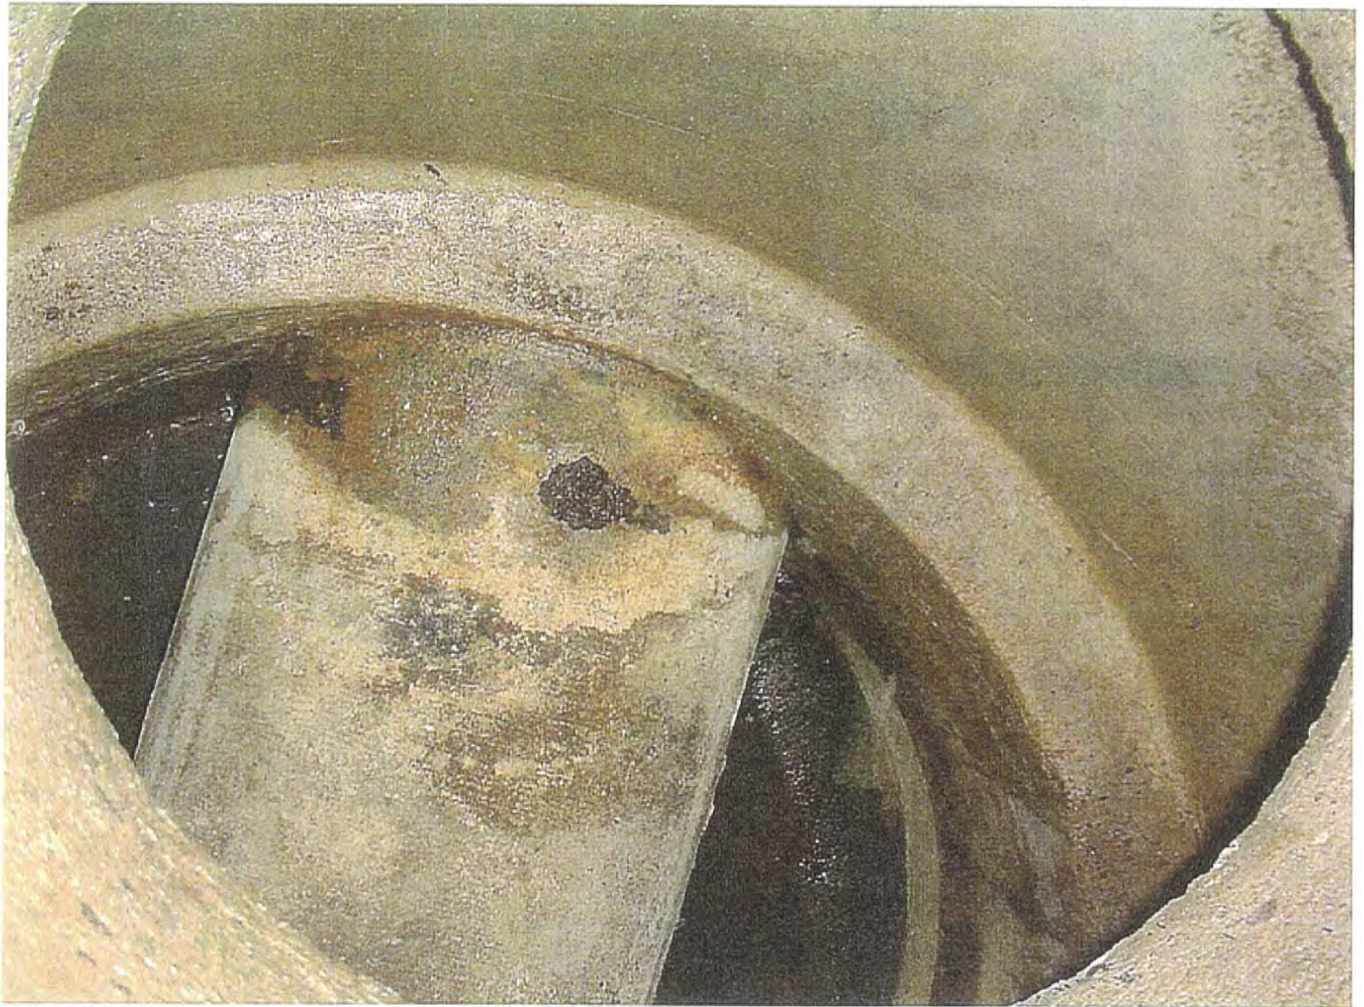
AIR RELEASE VALVE ASSEMBLY MANHOLE AT STATION 25+59
(Through Street at Legion Street)

Comments: No odor.
Storm water enters thru vent opening
Type A Type B

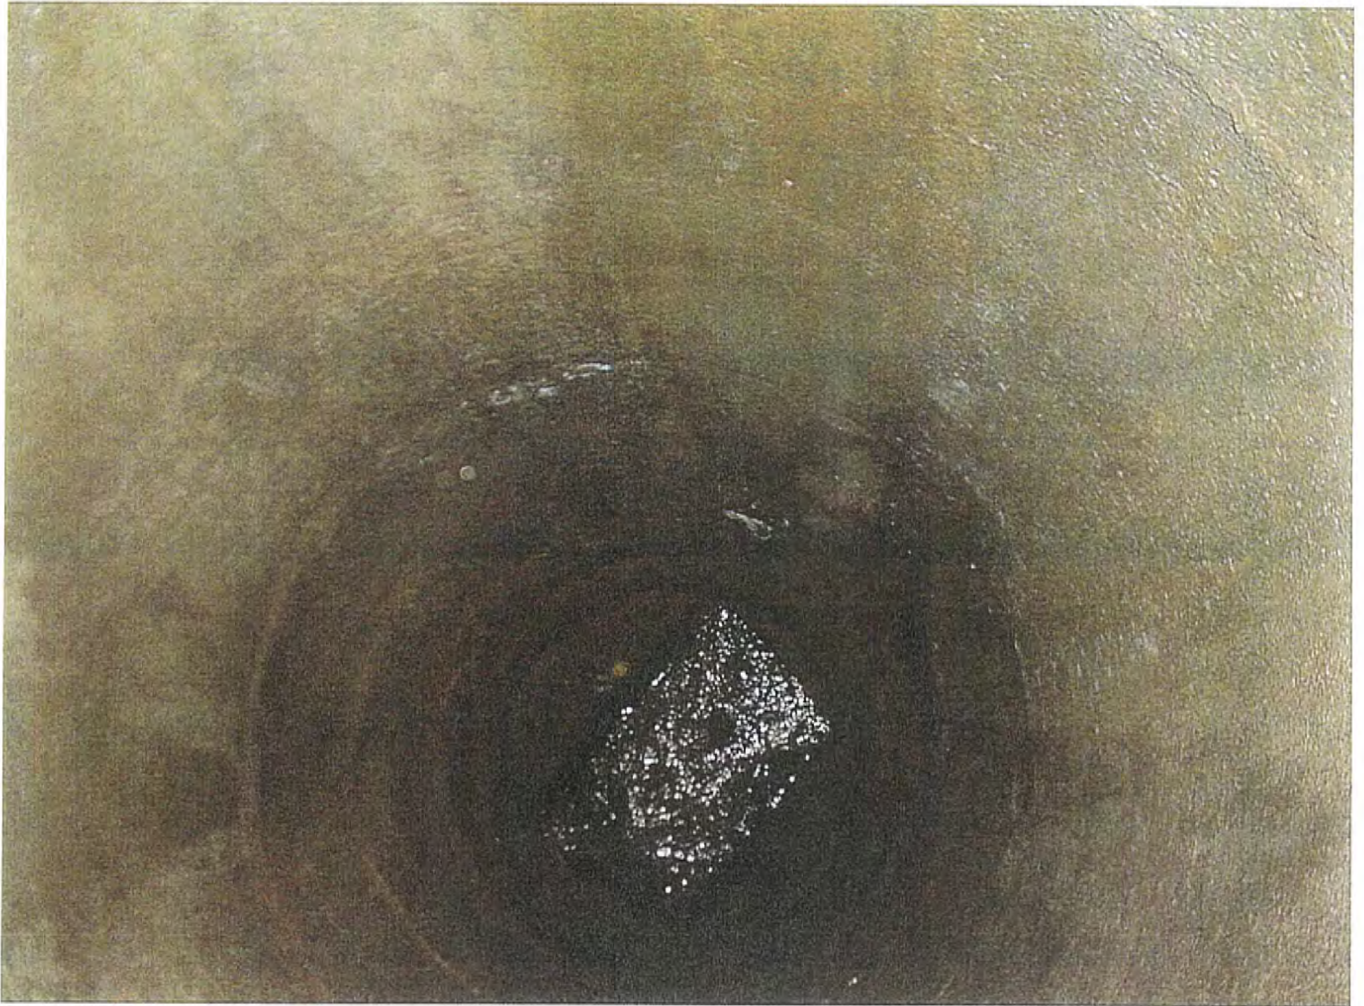
MANHOLE AT STATION 62+87
(Glenneyre Street at Cress Street)

Steps in MH - badly corroded - not safe
